# *Bridge Inspections*

Municipalities Could be Encouraged to  
Take More Action with Improved  
Communication of Deficiencies by the  
Agency of Transportation

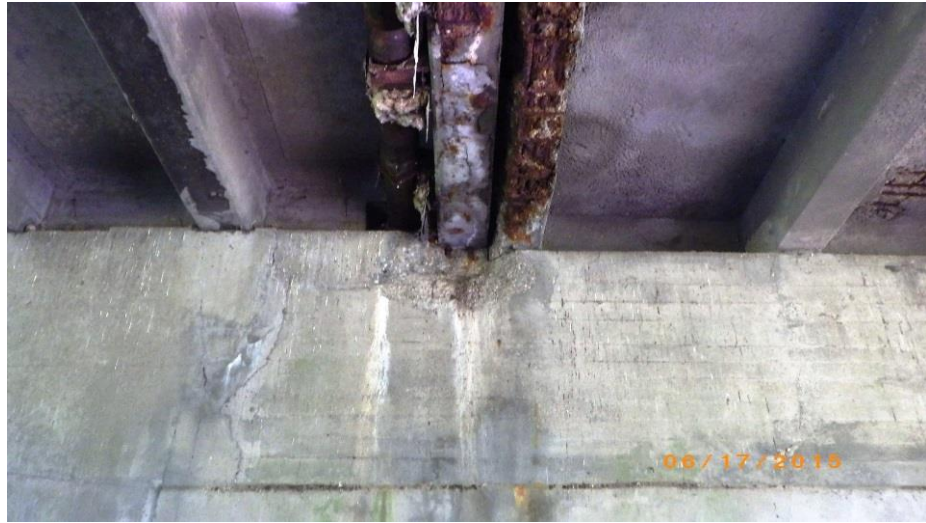
**Figure 5: Example of Concrete Deterioration on a Municipal-Owned Bridge**

*Concrete Deterioration.* Concrete is commonly used in bridge applications due to its compressive strength properties. In its inspection reports, VTrans pointed out deterioration in concrete elements, at times suggesting repairs or patches to deter further damage to the structure. See Figure 5 for an example of ongoing concrete deterioration.

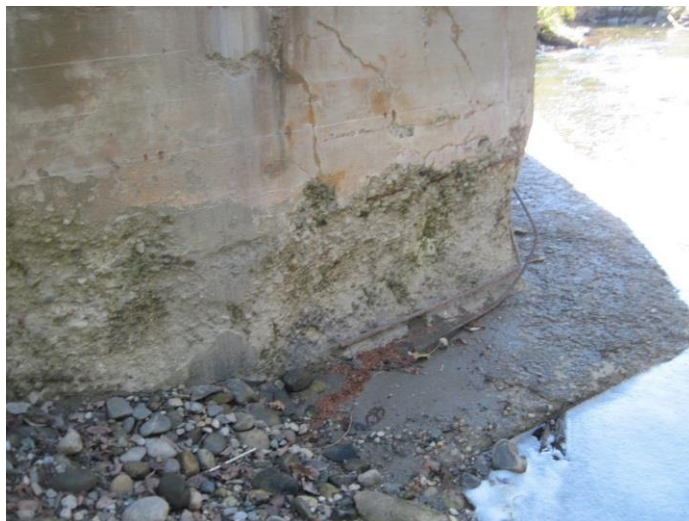
**Figure 6: Example of Effect of Scour on a Municipal-Owned Bridge**

*Scour.*<sup>14</sup> The physical conditions associated with the flow of water through the bridge may cause undermining of the slope, erosion of the banks, or realignment of the stream. In its inspection reports, VTrans pointed out waterway issues and sometimes suggested taking erosion control measures, such as adding stones or removing impediments to water flow. See Figure 6 for an example of an ongoing scour problem.

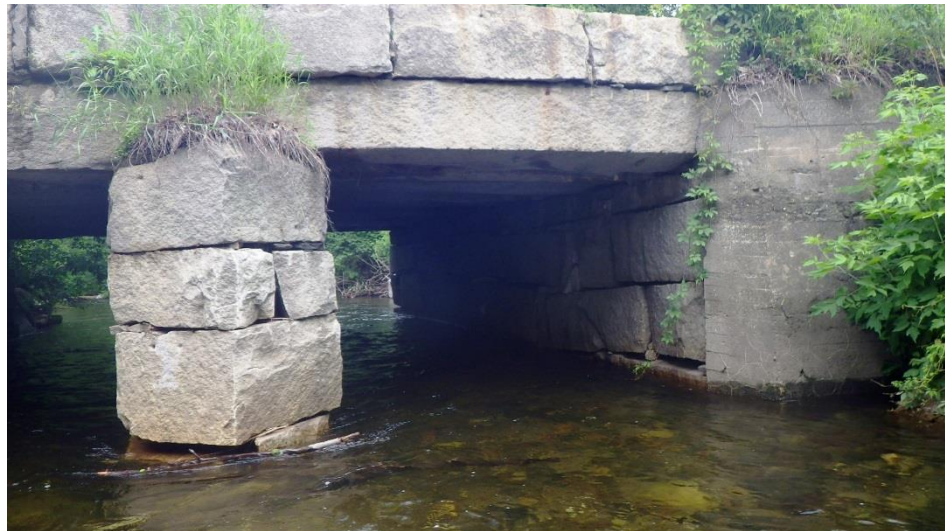
Voids in the abutments and the pier should be chinked with smaller stone.

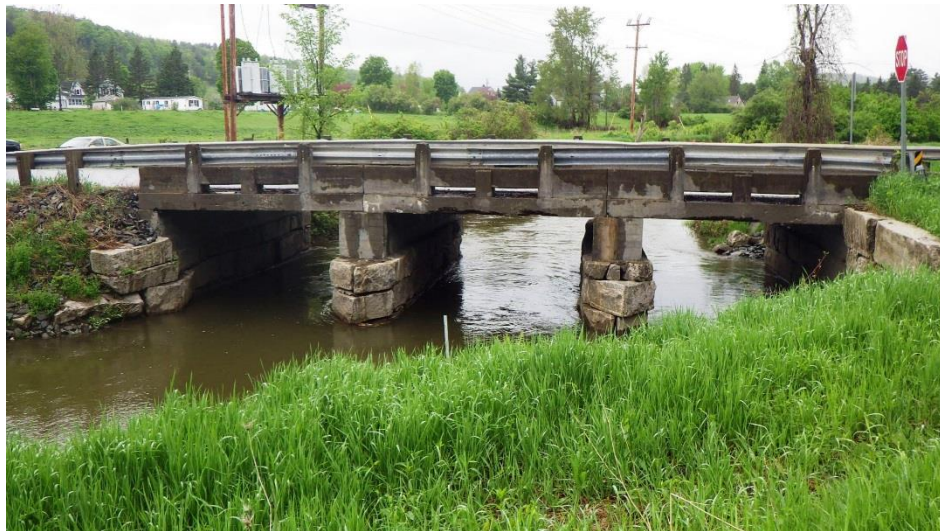
Structure in poor condition, including voids in the stone blocks of the abutments and piers.

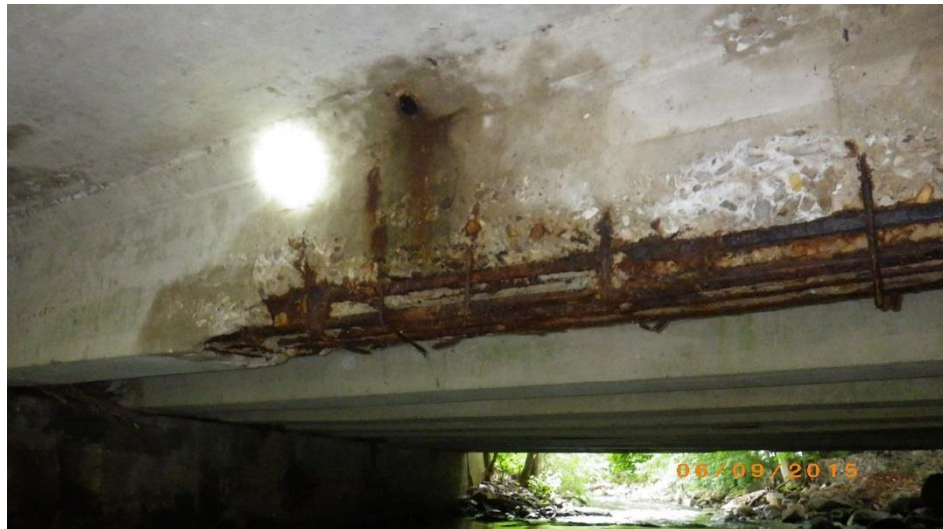
Extensive concrete repairs are needed.

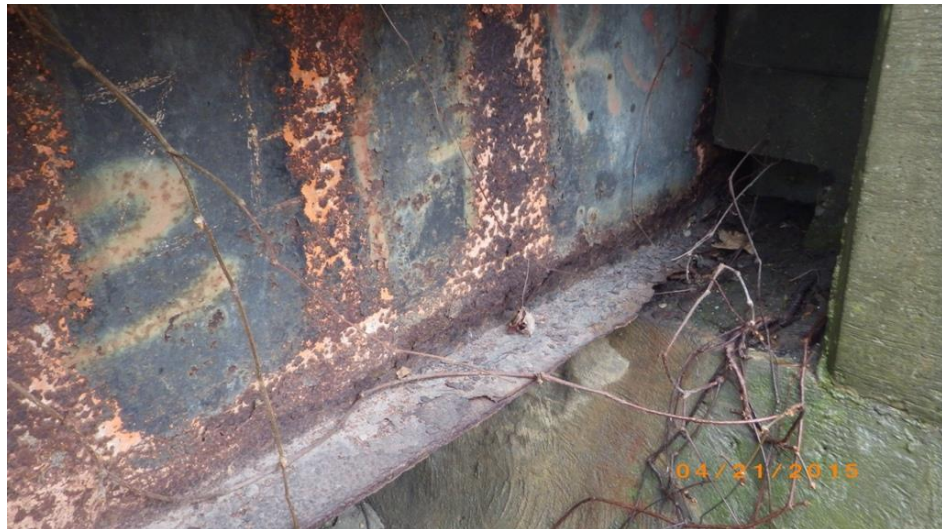
Repairs needed to supplement section loss in three beams. All beams need cleaning and painting.

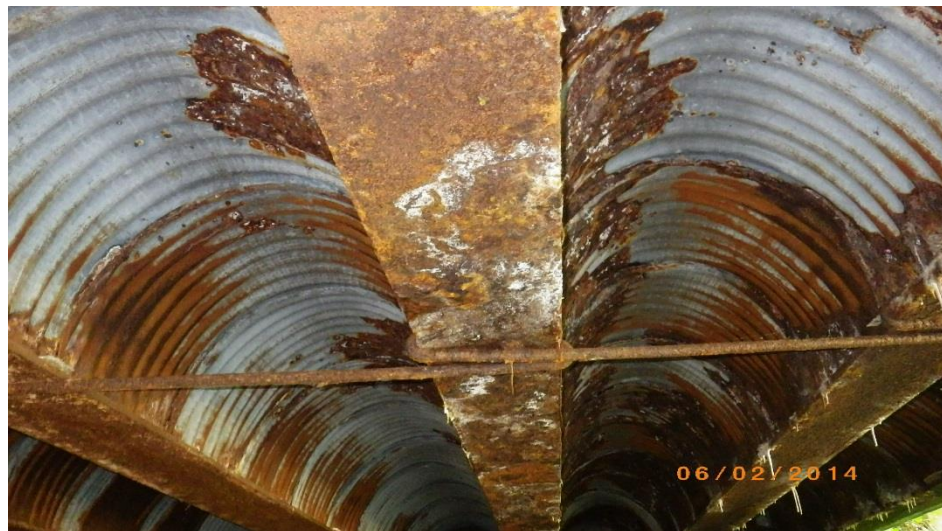
Deterioration of arches.

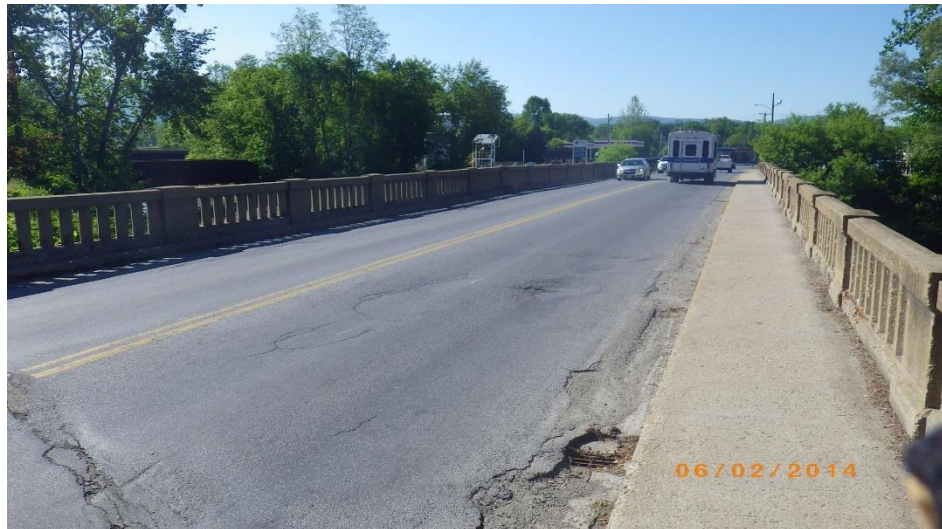
Structure needs to have a rehabilitation project and full deck replacement.

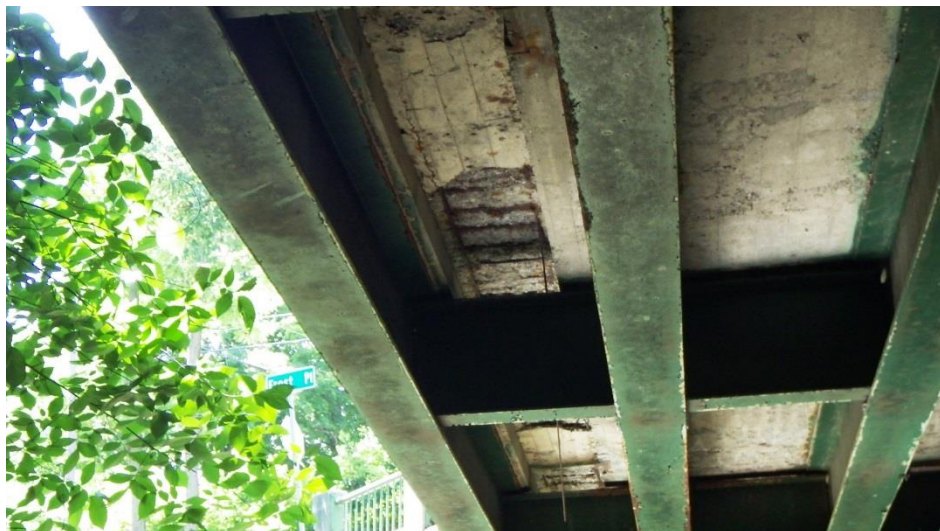
Deck will need rehabilitation in the near future.

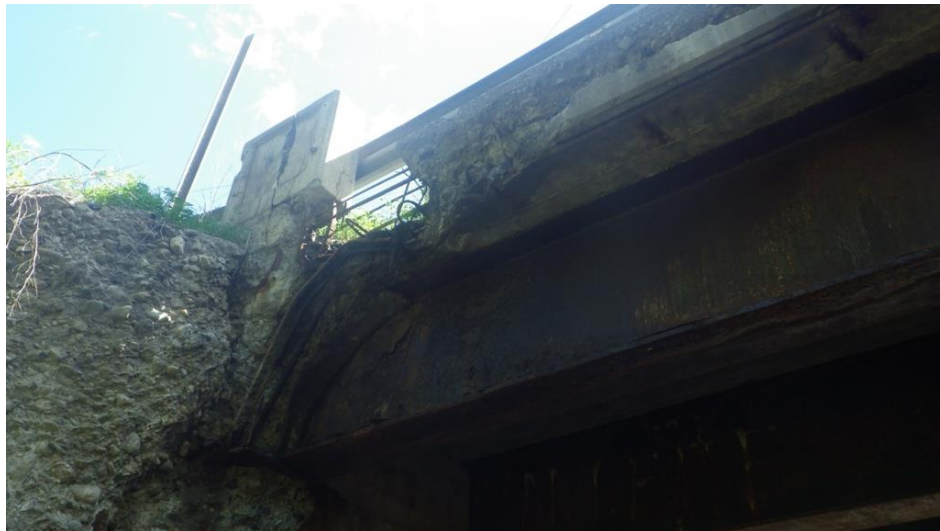
Concrete deterioration due to roadway runoff.

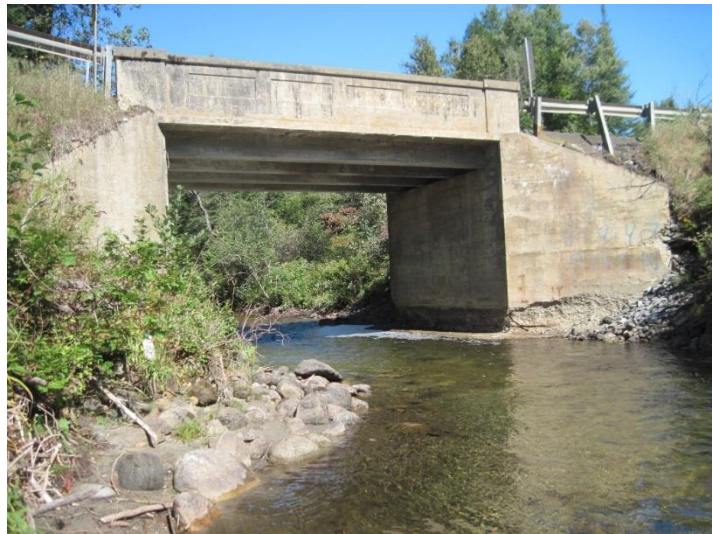
Approaches behind rail in corners need to be filled in with stone to prevent further deterioration.

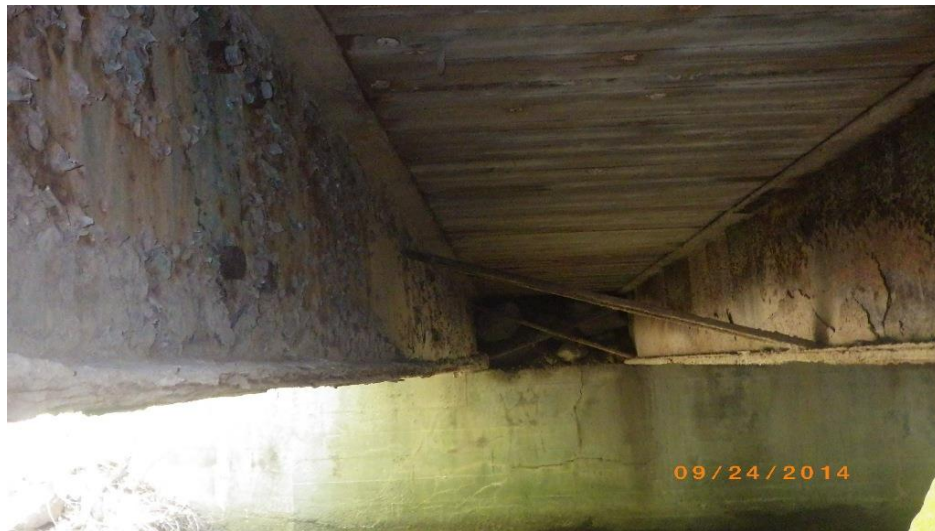
Deck and steel beam superstructure are reaching point for full replacement.

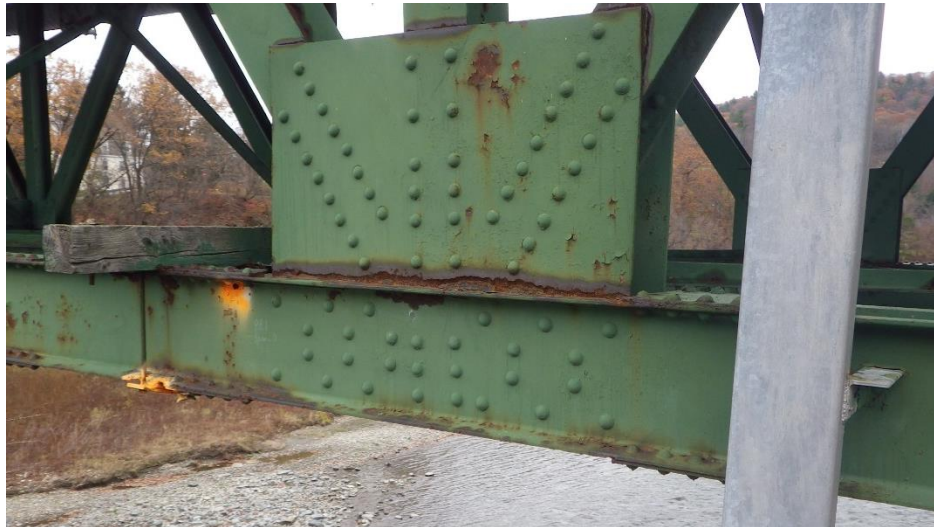
Deterioration along the lower node and bottom cord. Steel repairs and replacement of members is needed around these areas. The superstructure needs cleaning and painting.

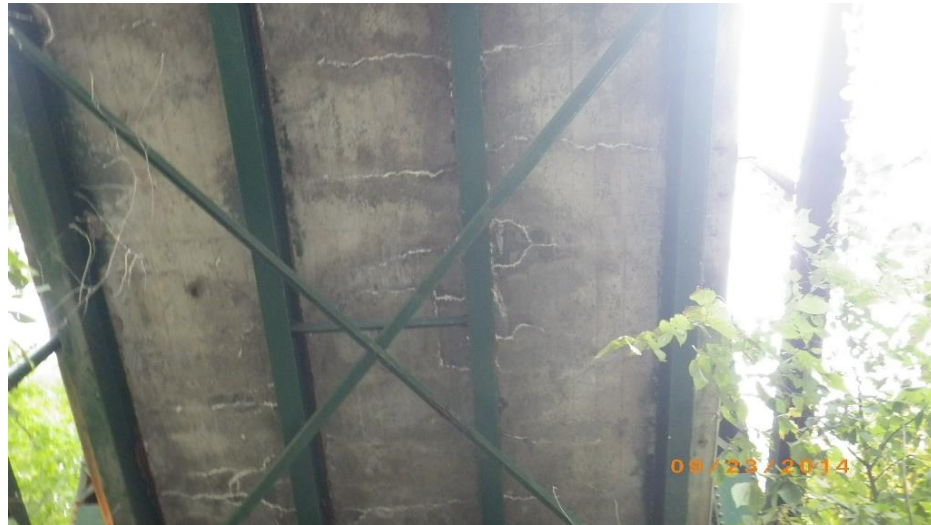
Deck needs full replacement

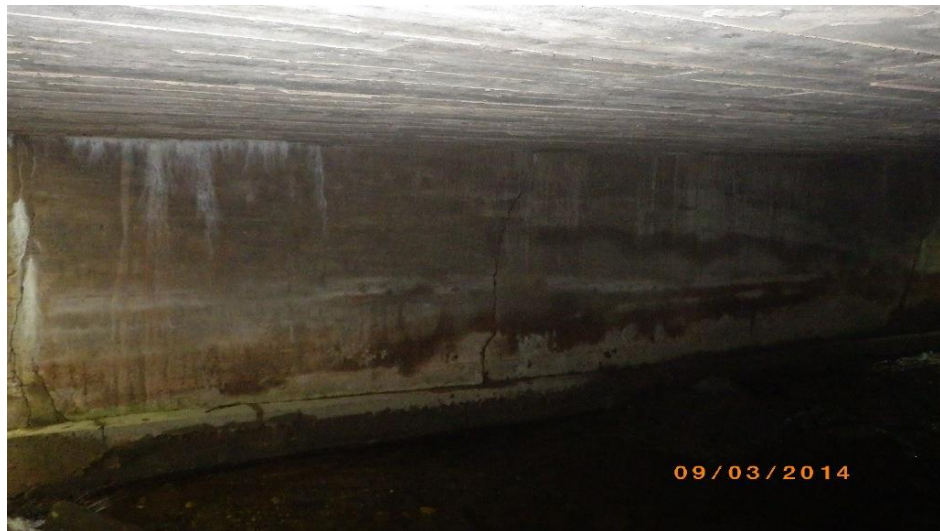
Past settlement damage along east abutment (no change in several years).

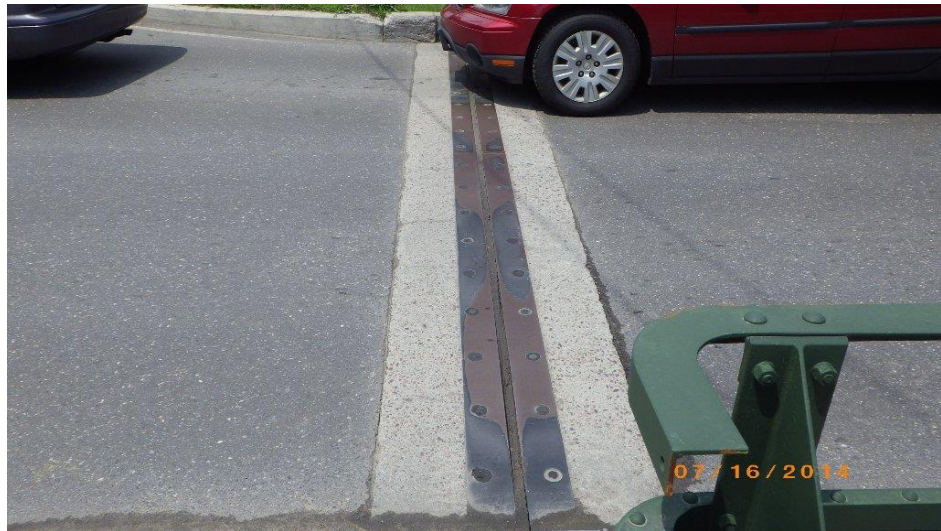
Fabric trough for the Vermont joint needs flushing out to keep corrosion at bay.

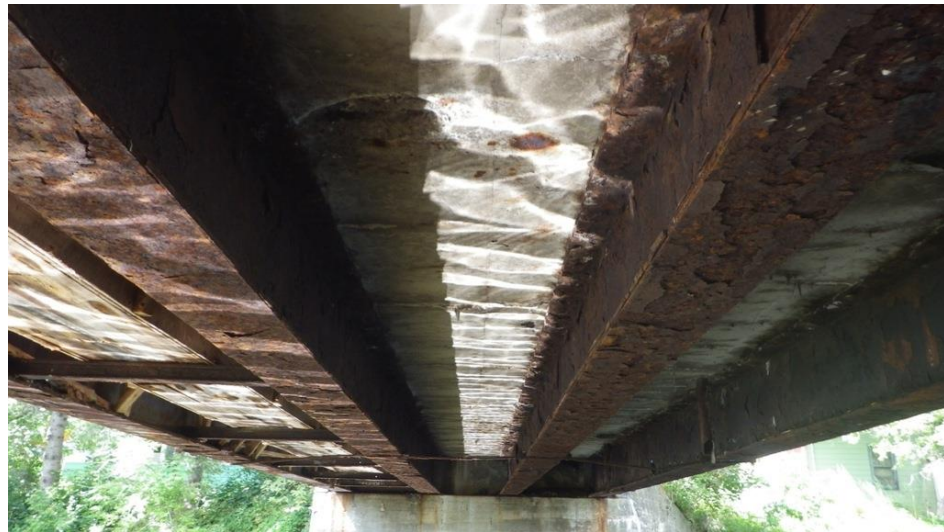
Beams have very heavy rusting and minor crushing at abutment 2 end. Bridge needs replacement or extensive reconstruction.

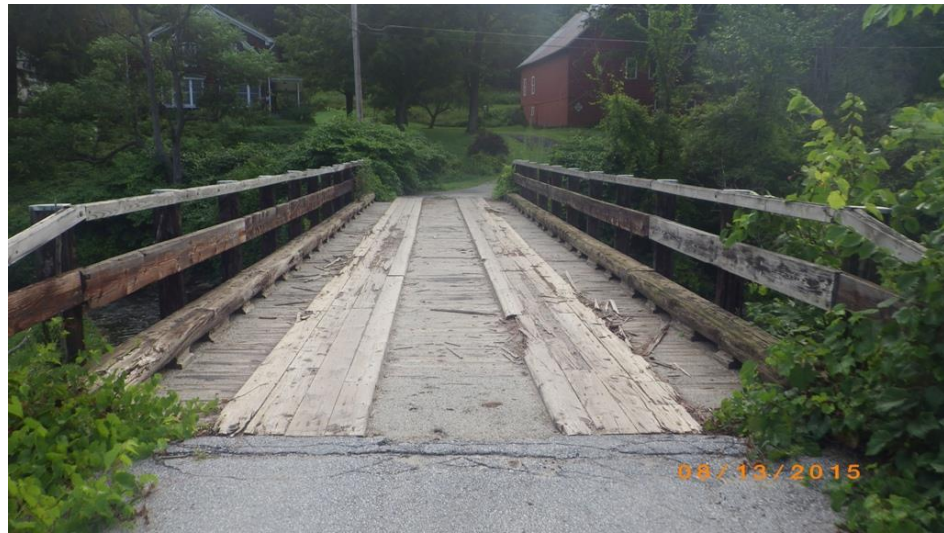
Runner planks damaged.

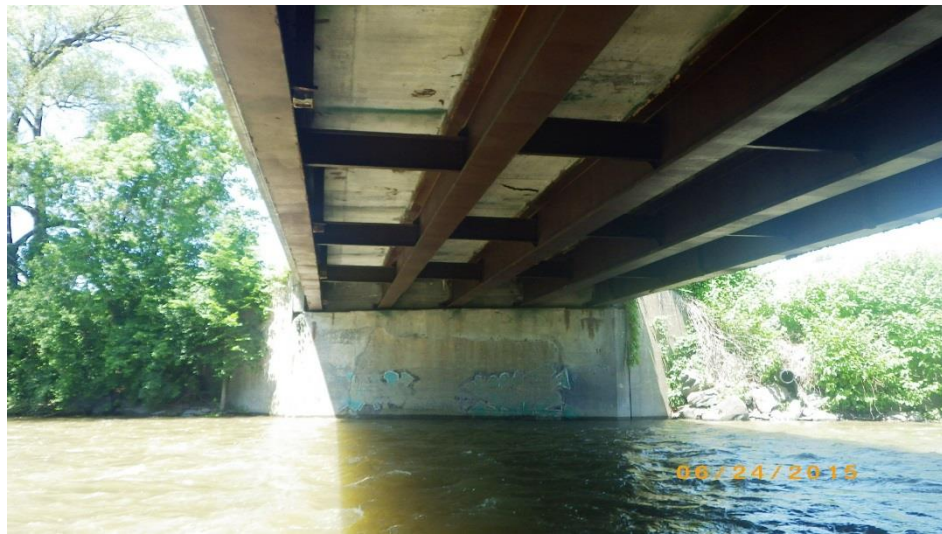
Abutments need cleaning and patch repair work

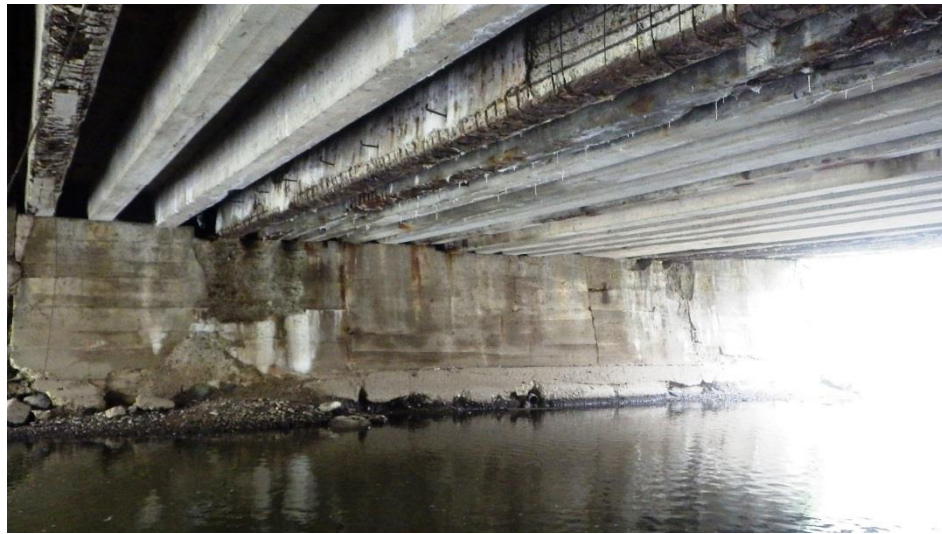
Heavy concrete damage along the western abutment stem and seats

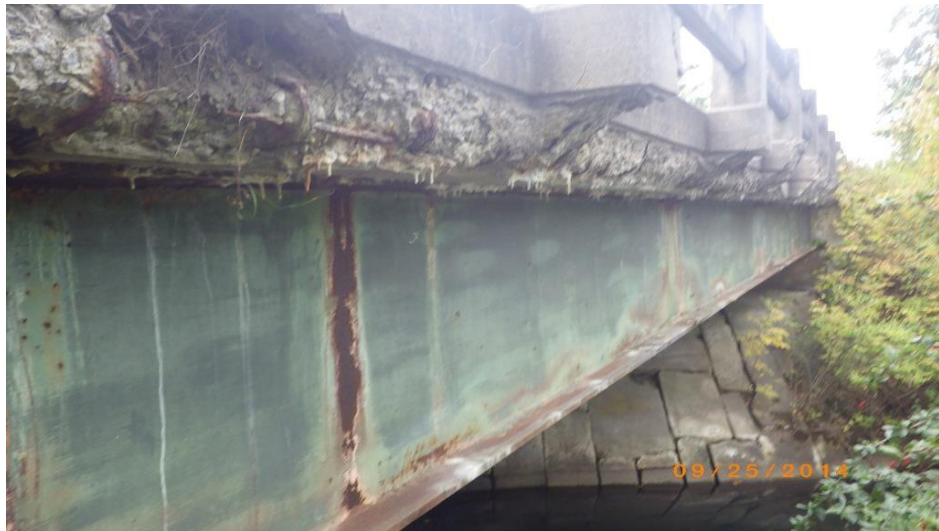
Bridge would benefit greatly from a deck replacement and cleaning and painting of steel superstructure.

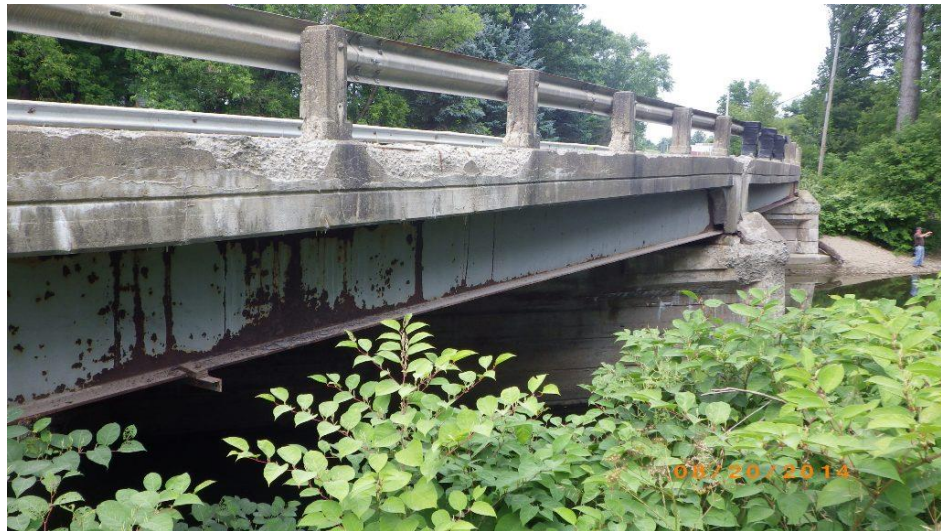
Deck is poor and bridge in need of extensive reconstruction.

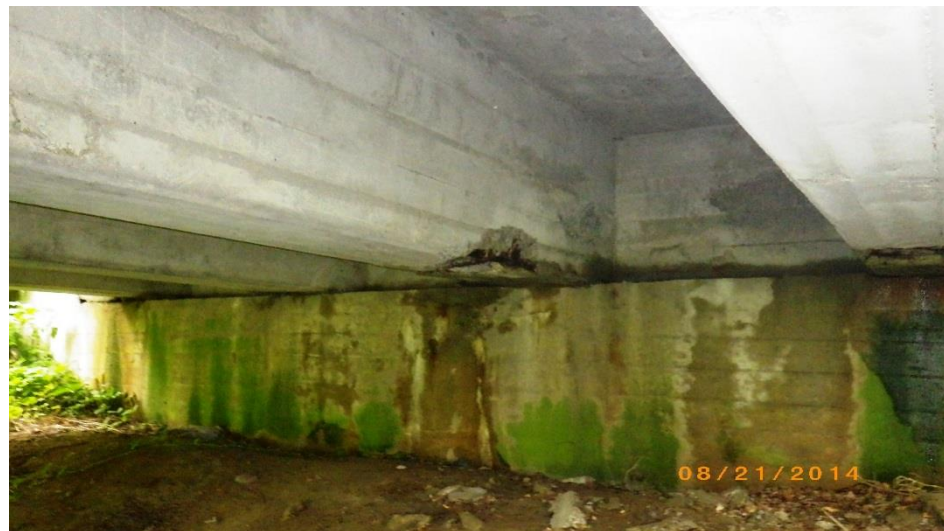
This structure should have concrete repairs to the piers and superstructure.

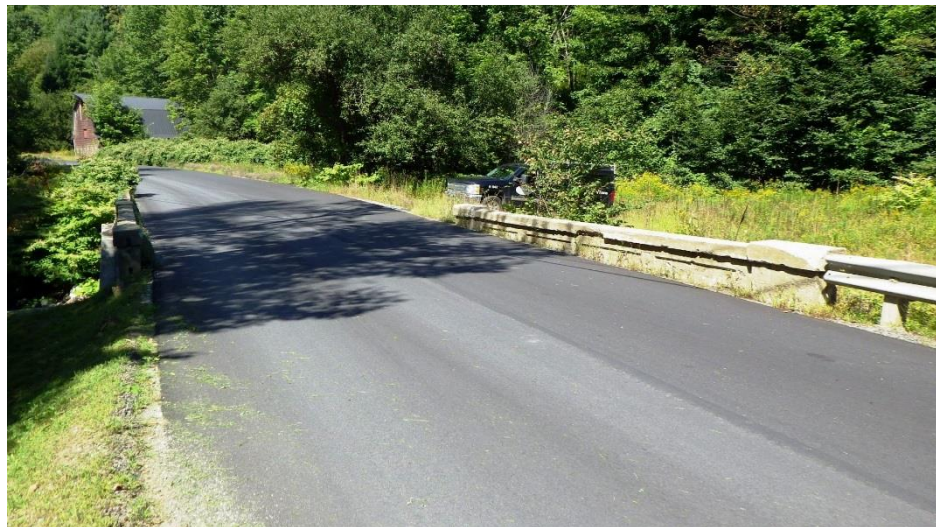
Approach rail should be raised to meet standards.

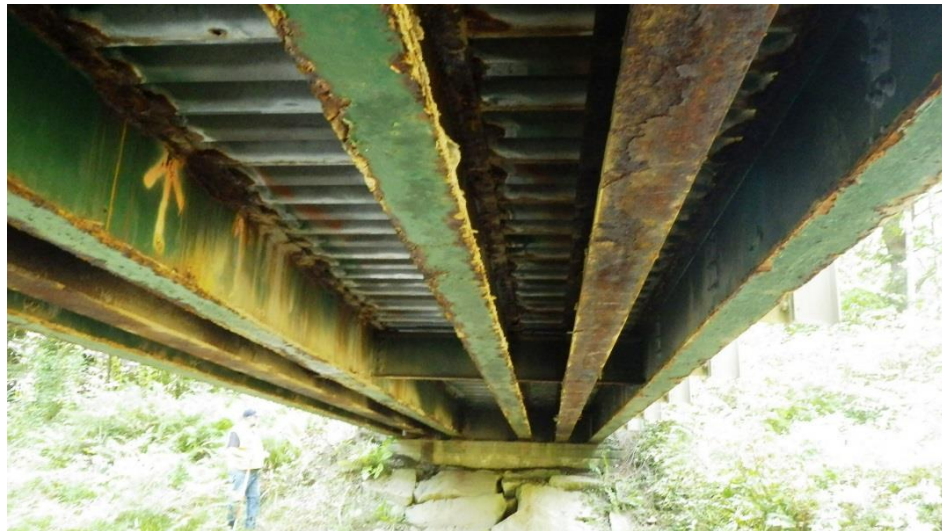
Beams are in poor condition.

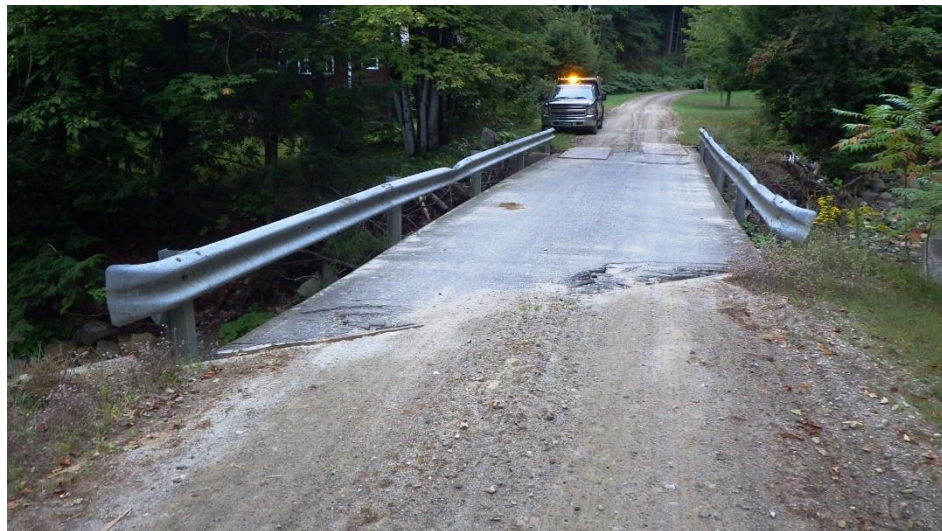
The deck is in poor condition and should be replaced soon.

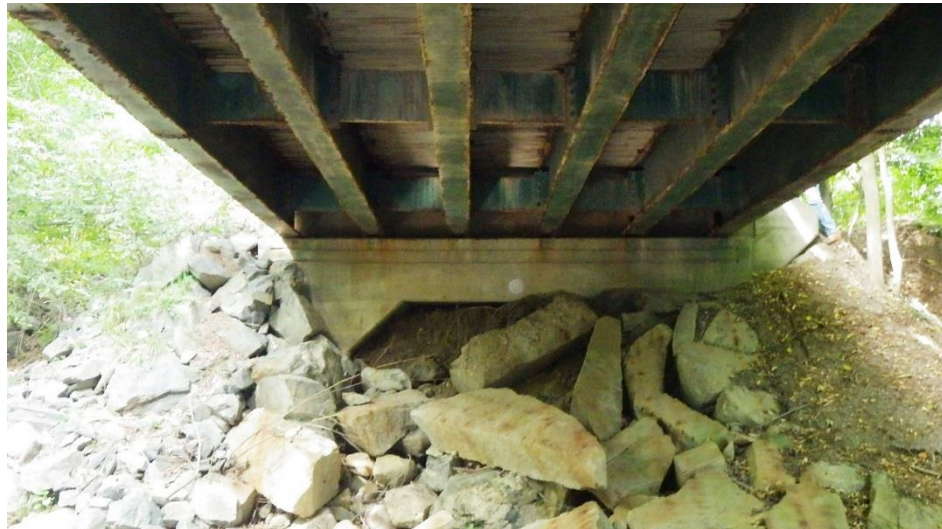
Riprap on abutment 2 side should be repaired.

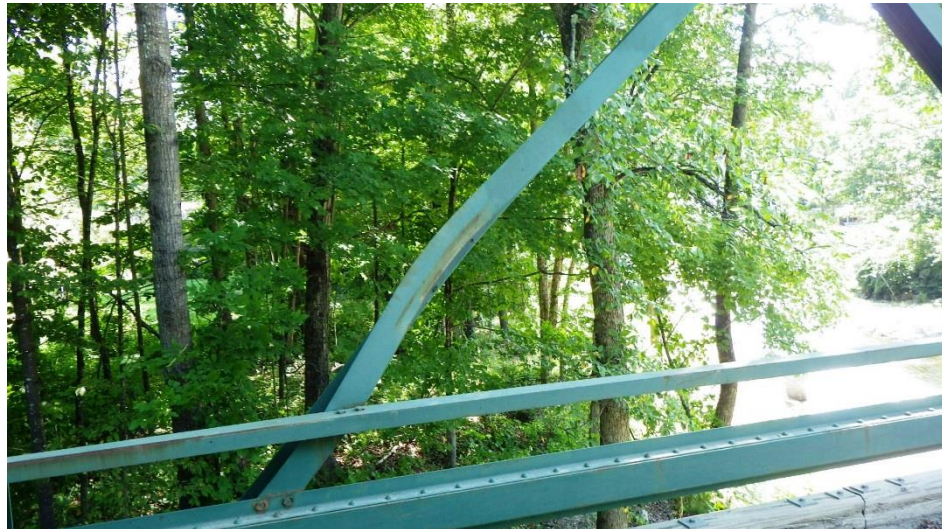
Diagonal bracing on the downstream side should be replaced.

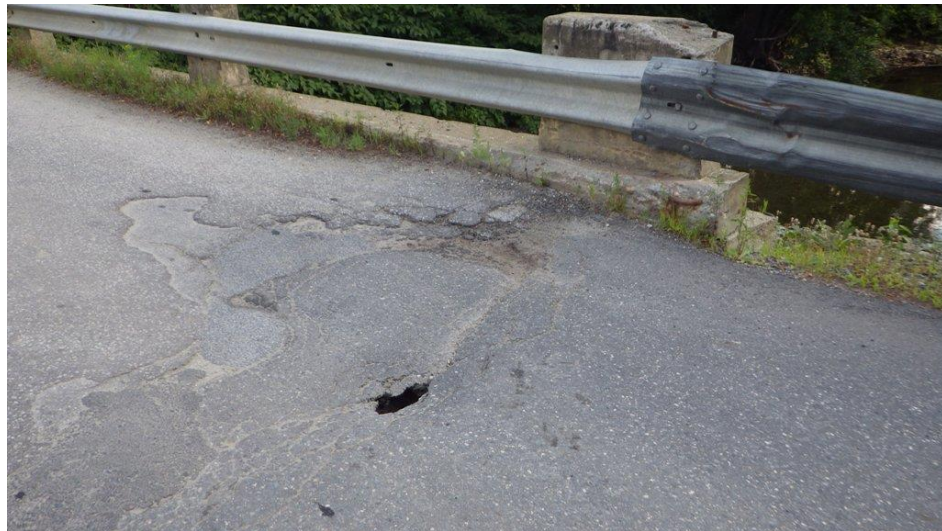
Full-depth hole has occurred along backwall (the topmost portion) of abutment 1.

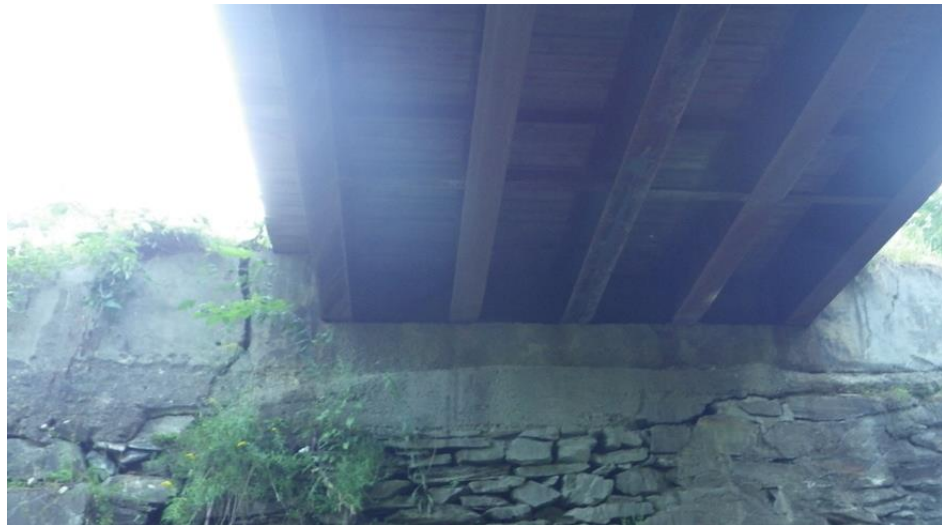
Laid-up stone at abutment needs chinking and mortar repairs.

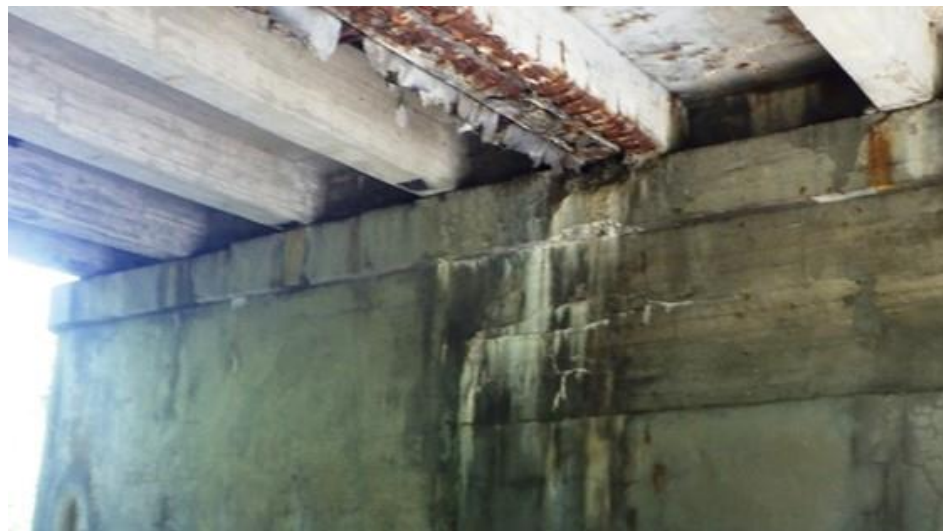
Concrete loss and substructure deterioration.

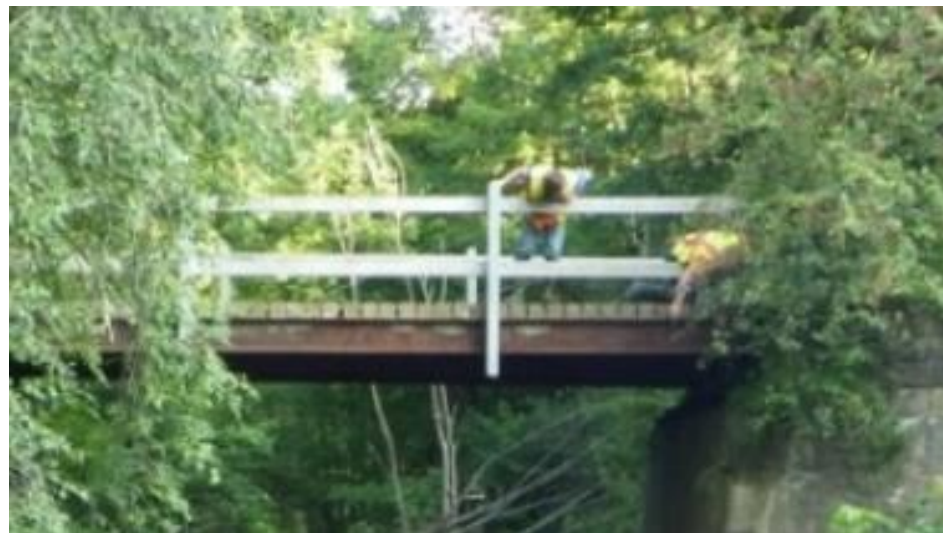
Structure deterioration is progressing. Steel superstructure is going to need replacement in five years or less.

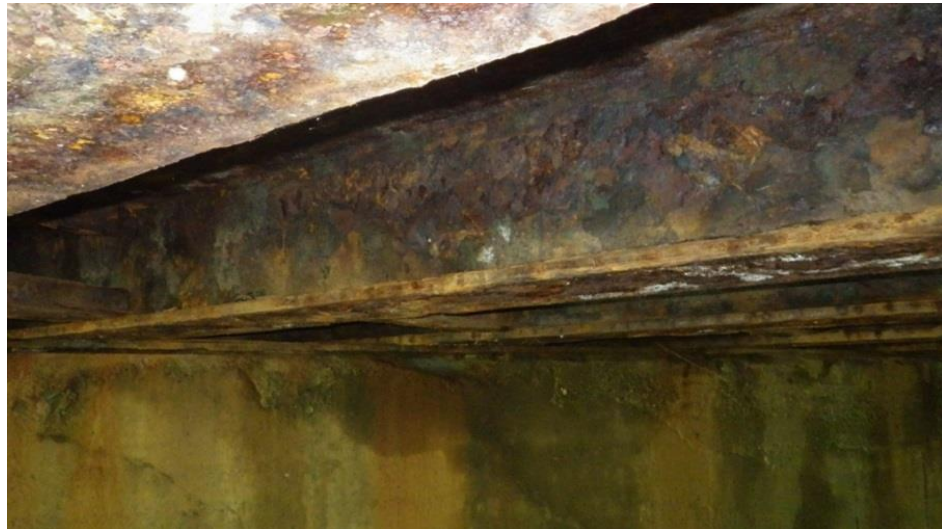
Beams need to be cleaned and painted due to heavy rusting,

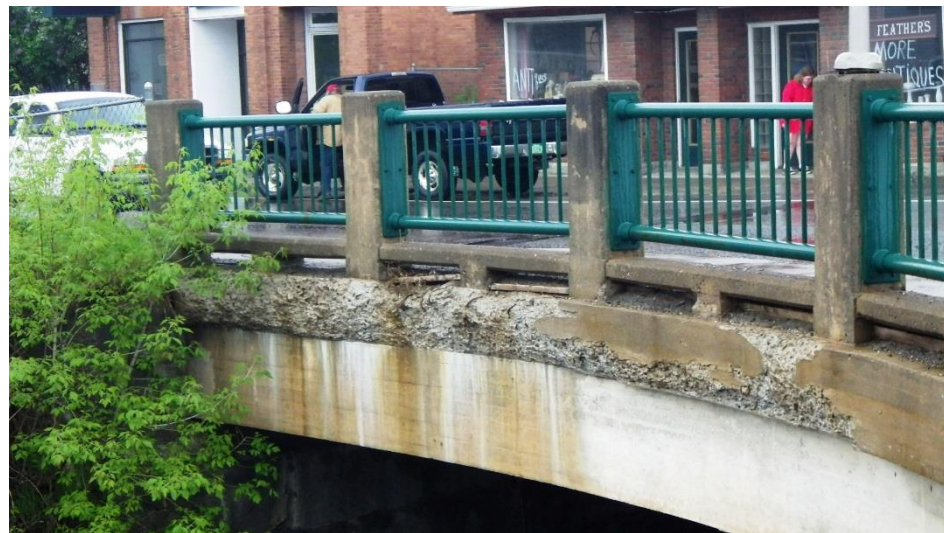
Deck deteriorating.

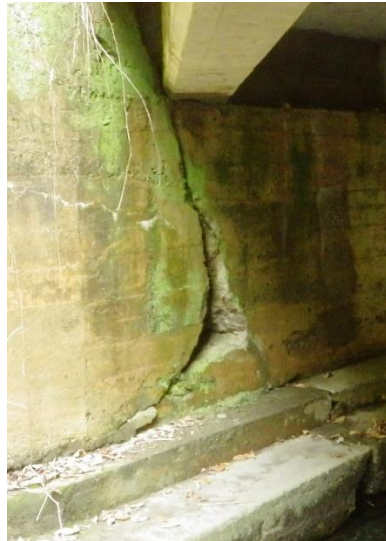
VTrans found abutment wall and footing damage but did not include this information in the report available to Randolph on VTransparency.

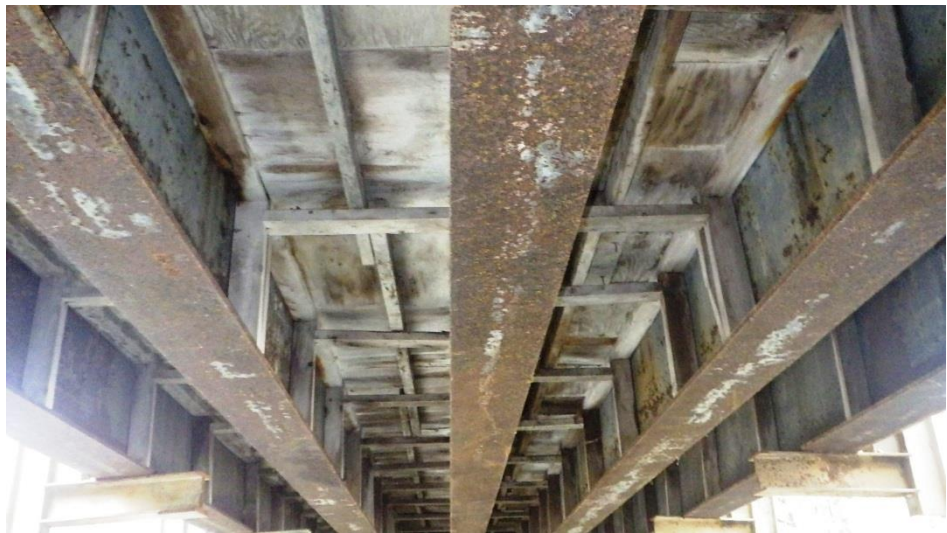
Upgrade to superstructure and deck (within the next 10 years) should be considered.

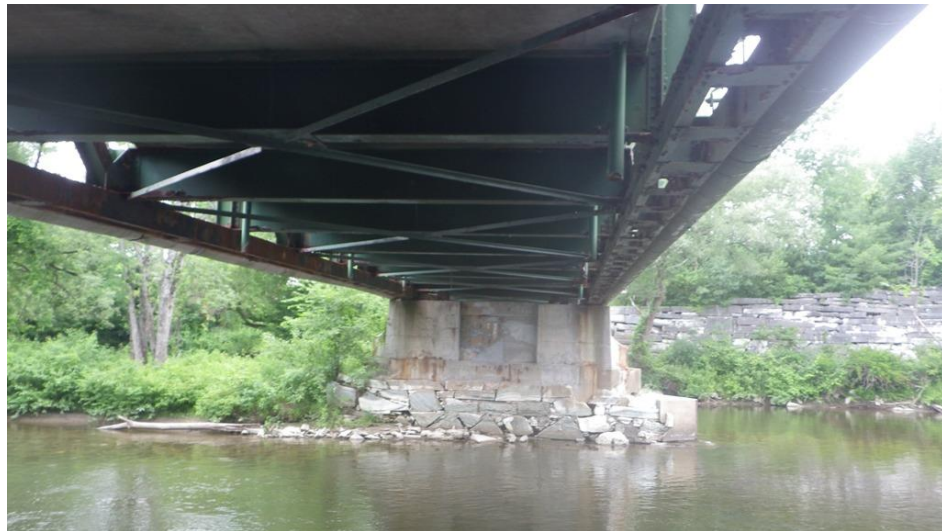
Pony truss in poor condition along steel superstructure.

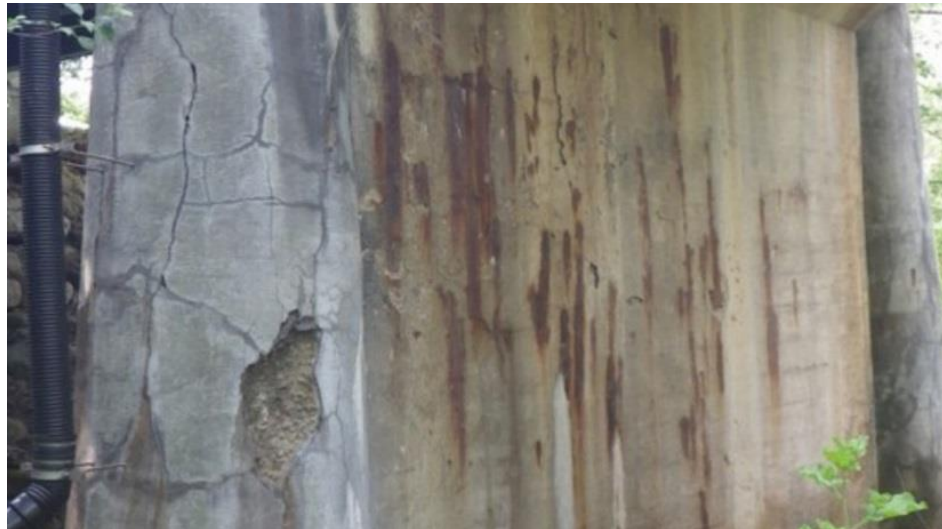
Pier columns need to be repaired as there is heavy cracking and concrete deterioration.

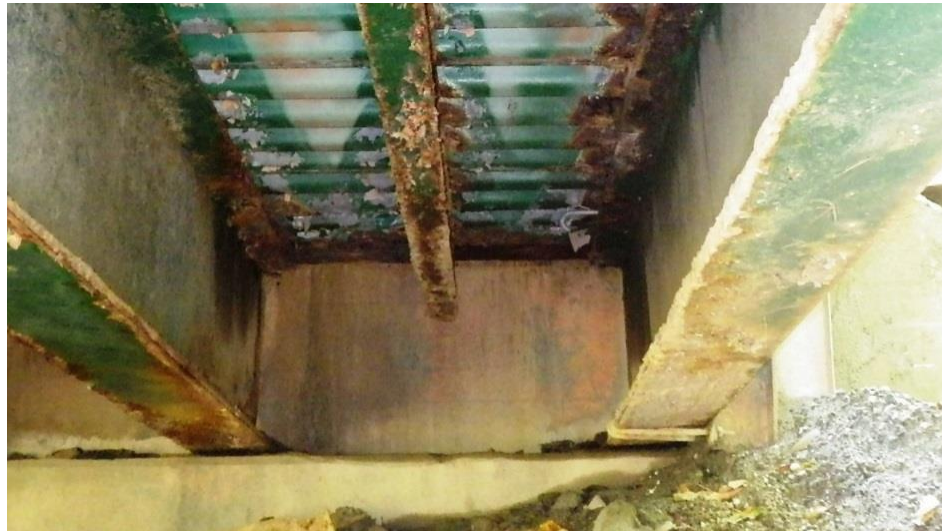
Deck and superstructure will need replacement in the very near future.

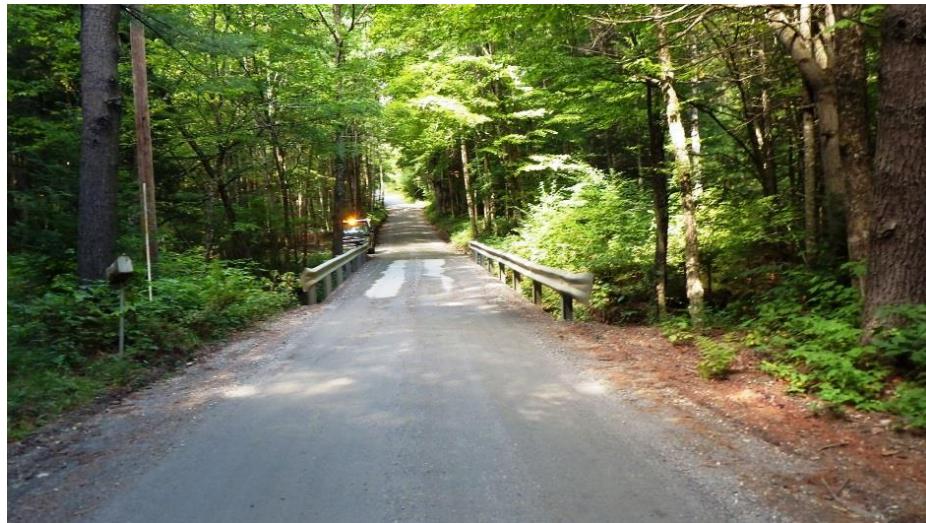
Bridge and approach rail should be replaced.

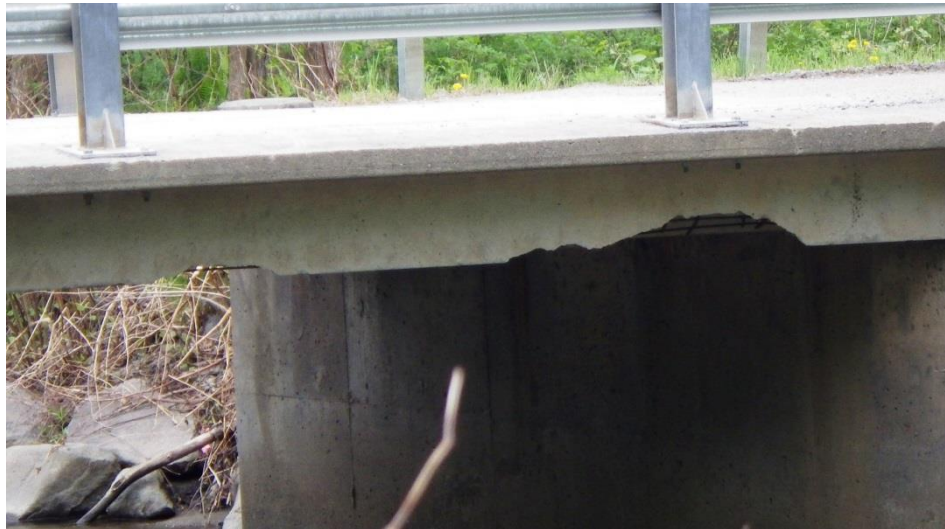
Tension cable is in good condition. Beam/cable unit should be replaced before tension cable rusts beyond repair.

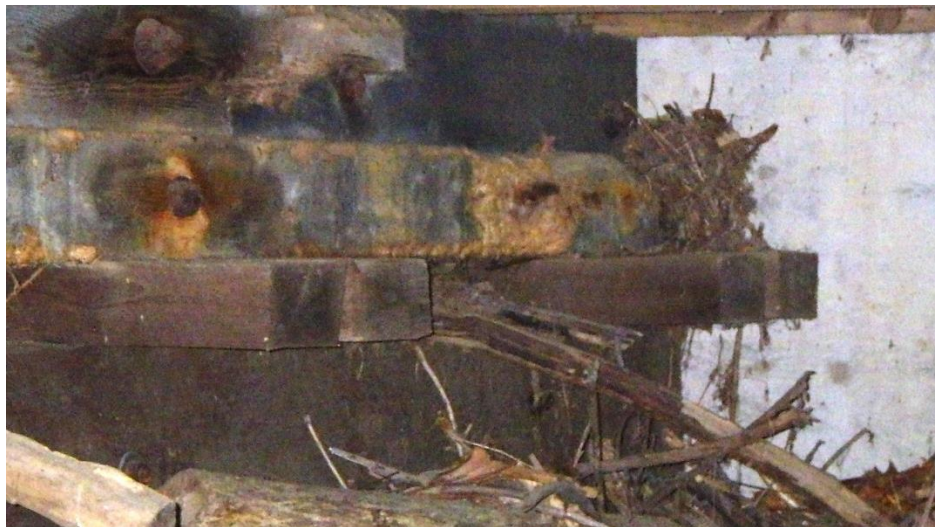
Structure should be sprayed with animal repellent to prevent chewing.

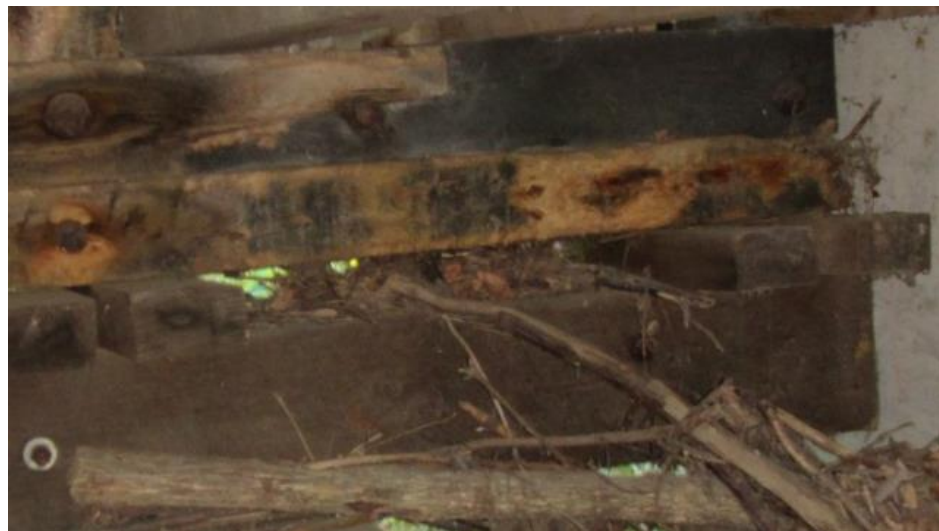
**Photo from Latest VTrans Inspection**

Weathersfield sprayed structure with ammonia and multi-purpose cleaner, but damage from animals continues.

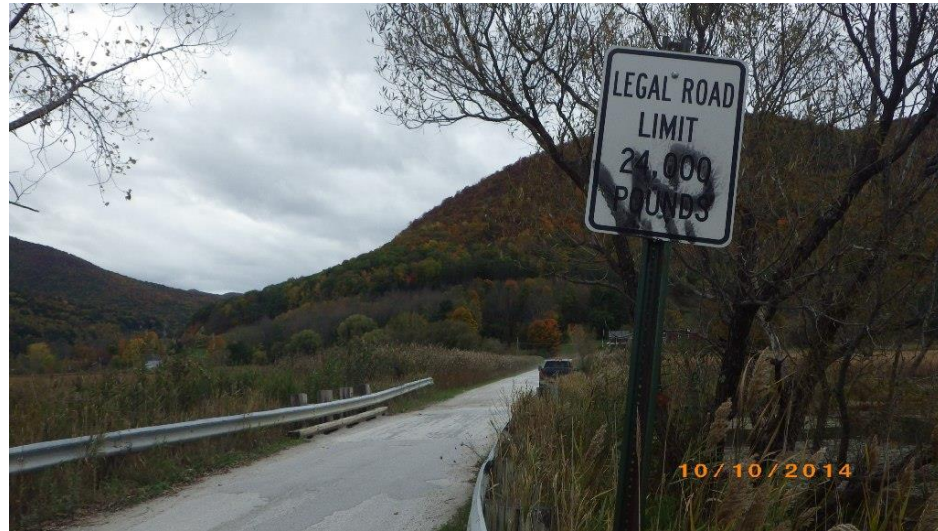
Load posting sign vandalized with spray paint.

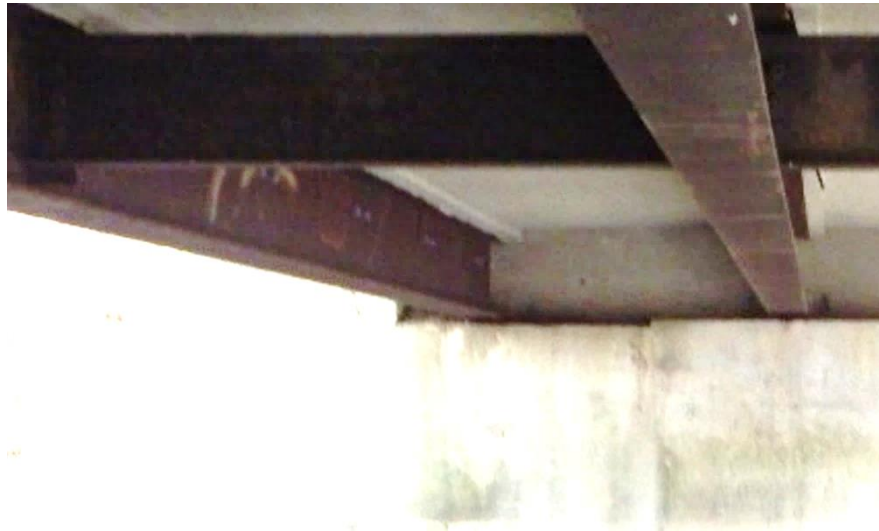
Consider cleaning and painting and greasing the last few feet of the beam ends to deter further corrosion.
