# *Bridge Inspections*

Municipalities Could be Encouraged to  
Take More Action with Improved  
Communication of Deficiencies by the  
Agency of Transportation

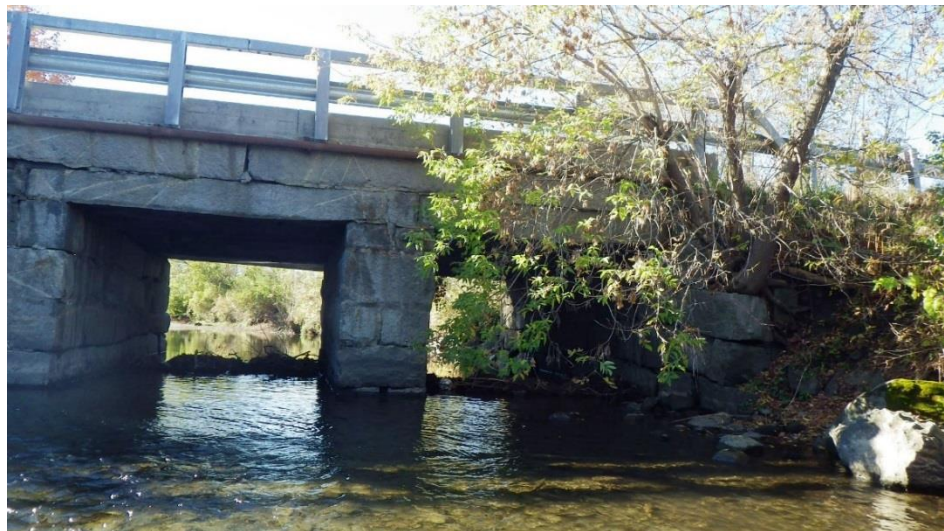
**Photo and Finding from 2014 VTrans Inspection**

Timber debris in spans 3 and 4 should be removed.

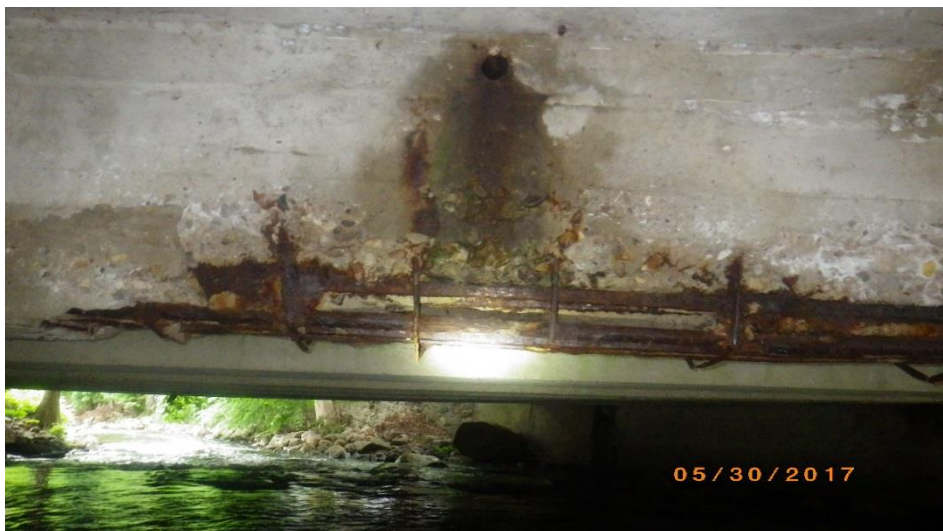
**Photo from Latest VTrans Inspection**

VTrans is evaluating alternatives as part of town highway bridge program.

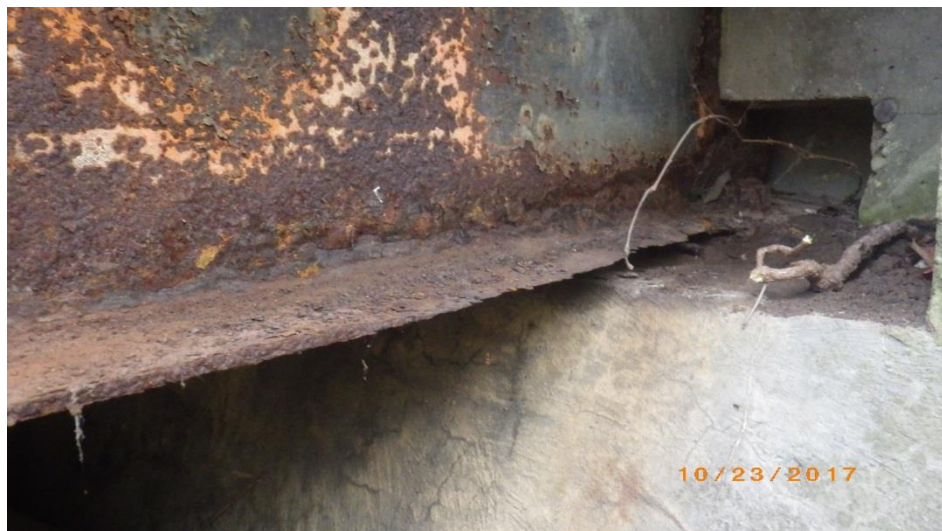
**Photo from Latest VTrans Inspection**

Bennington has not acted to address issue as of December 2017.

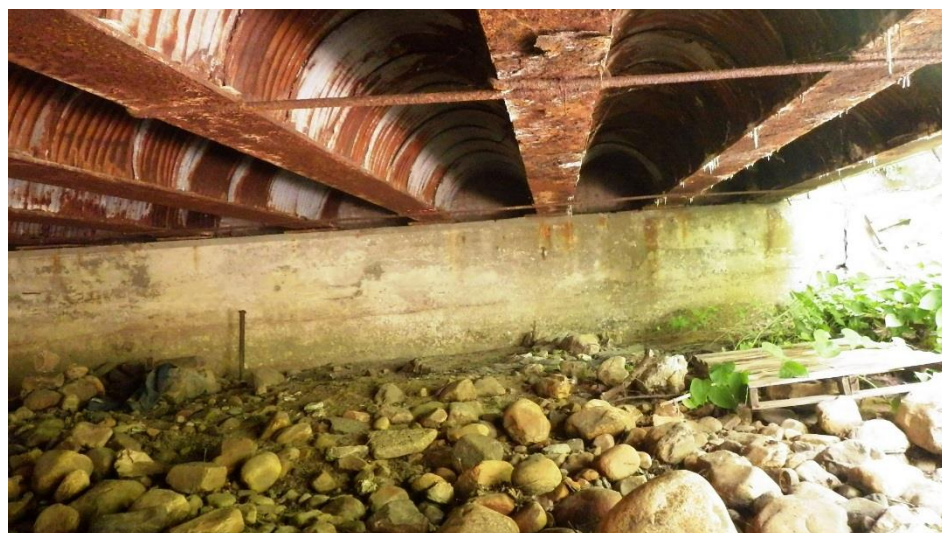
**Photo from Latest VTrans Inspection**

Bennington has not acted to address issue as of December 2017.

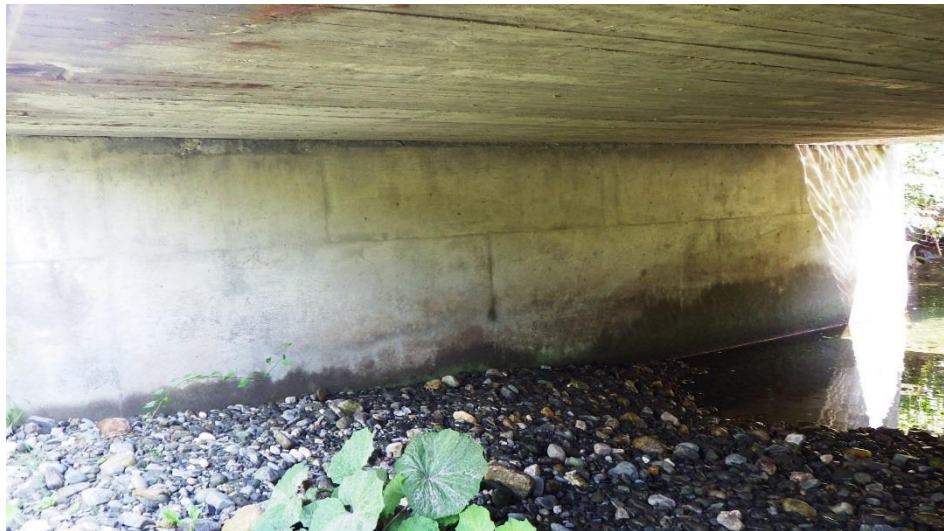
**Photo and Finding from 2014 VTrans Inspection**

Gravel bar should be removed.

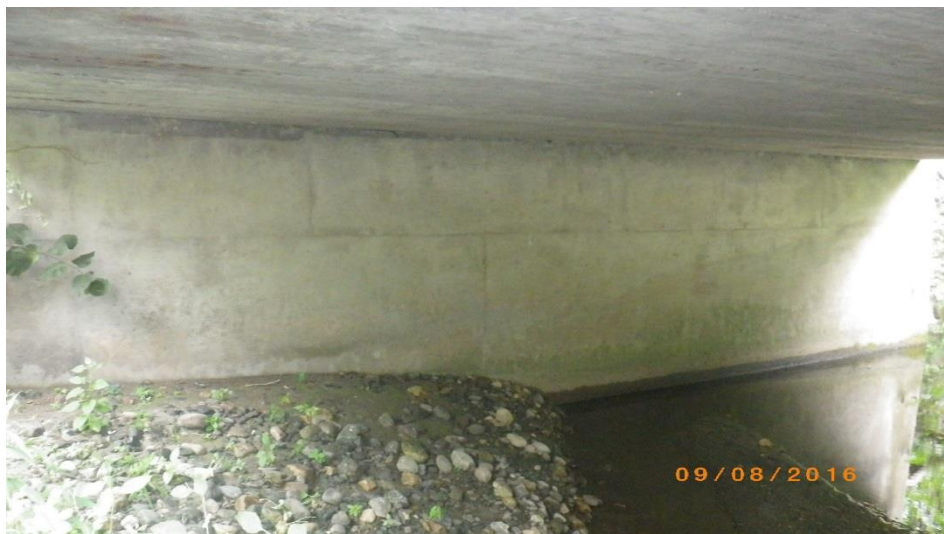
**Photo from Latest VTrans Inspection**

Brattleboro has not acted to address issue as of January 2018.

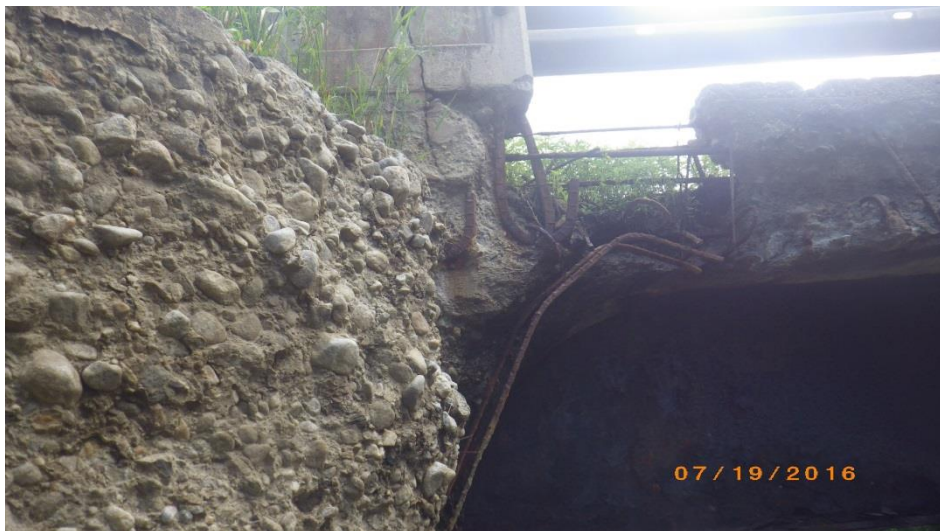
**Photo from Latest VTrans Inspection**

Burke has not acted to address issue as of November 2017.

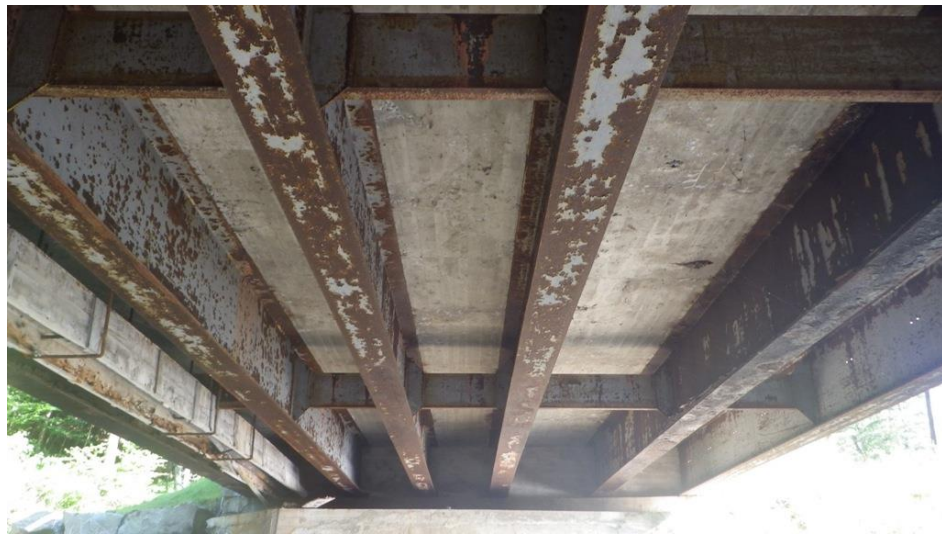
**Photo and Finding from 2014 VTrans Inspection**

Steel should be cleaned and painted.

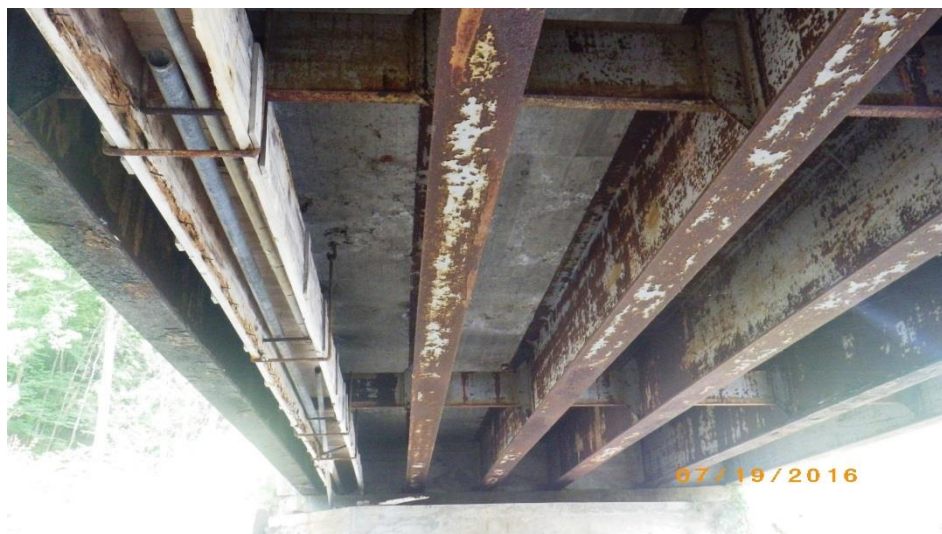
**Photo from Latest VTrans Inspection**

Burke has not acted to address issue as of November 2017.

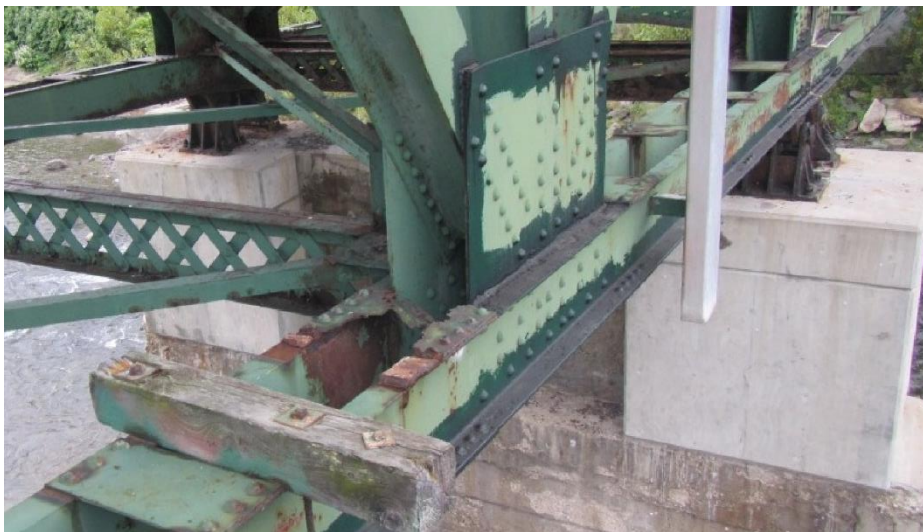
**Photo from Latest VTrans Inspection**

Hartford partially addressed issue by greasing lower node in some areas, which temporarily protects the steel elements. VTrans is evaluating alternatives as part of town highway bridge program.

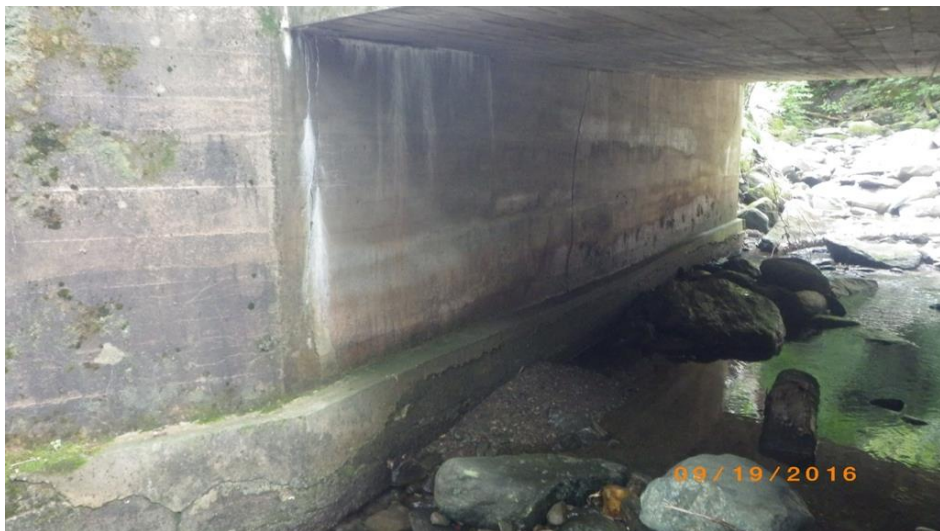
**Photo from Latest VTrans Inspection**

Montgomery has not acted to address issue as of November 2017.

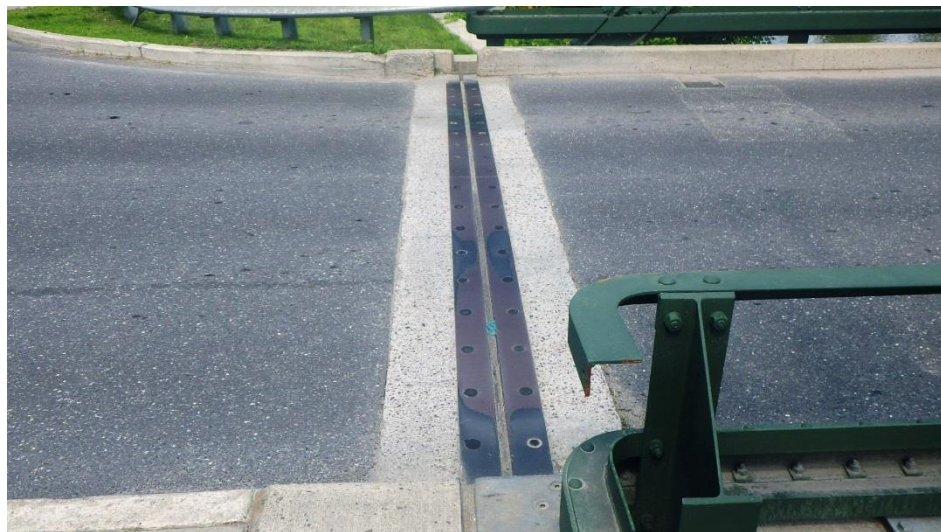
**Photo from Latest VTrans Inspection**

Montpelier has not acted to address issue as of December 2017; bridge cleaning and greasing planned for 2018.

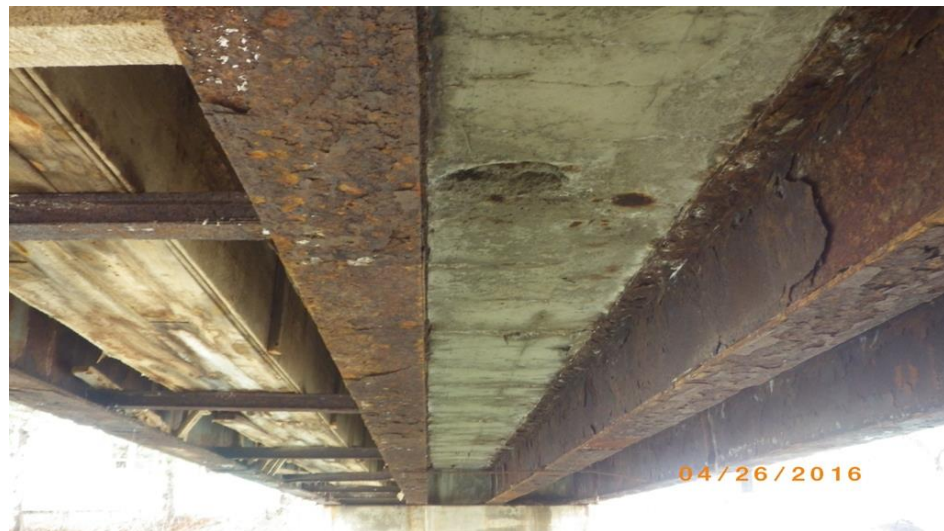
**Photo from 2016 VTrans Inspection**

VTrans plans to replace bridge in 2019 as part of town highway bridge program.

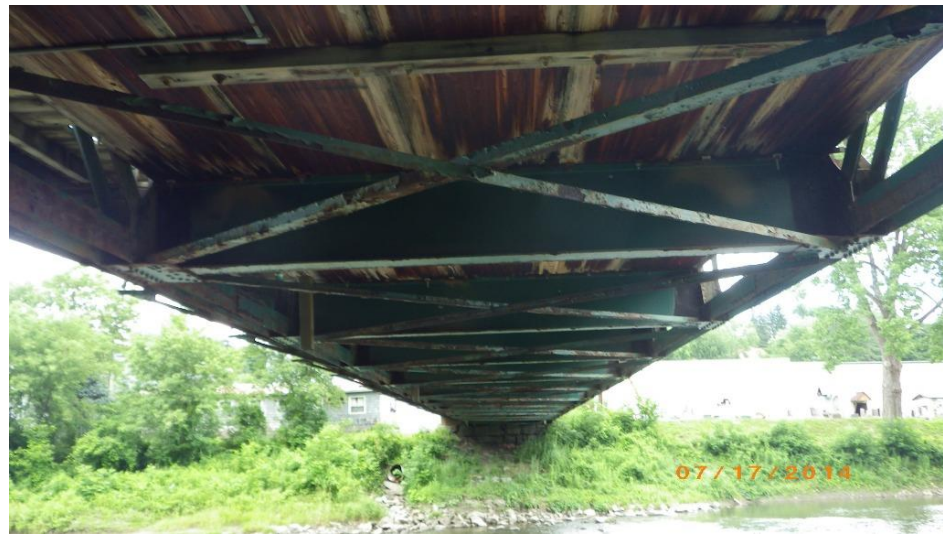
**Photo and Finding from 2014 VTrans Inspection**

Steel superstructure needs extensive cleaning and painting.

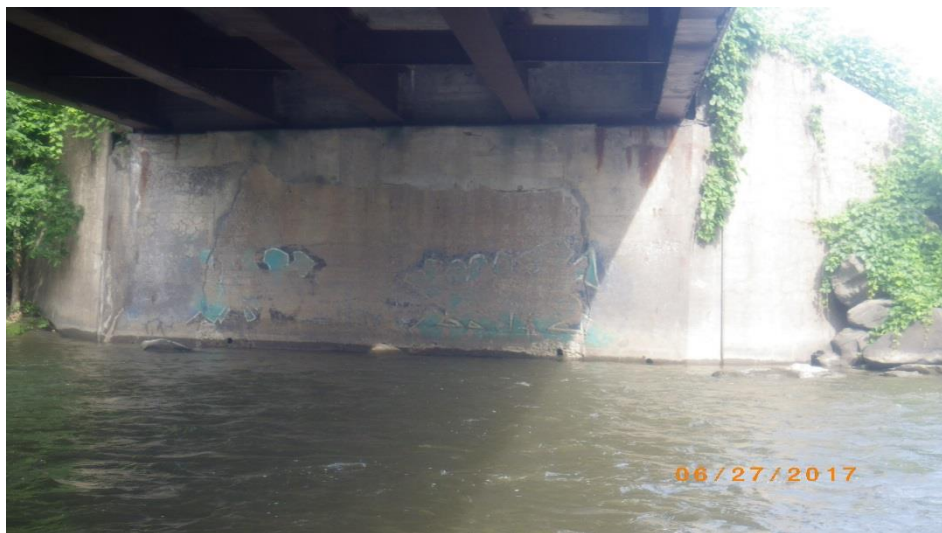
**Photo from Latest VTrans Inspection**

Montpelier has not acted to address issue as of December 2017.

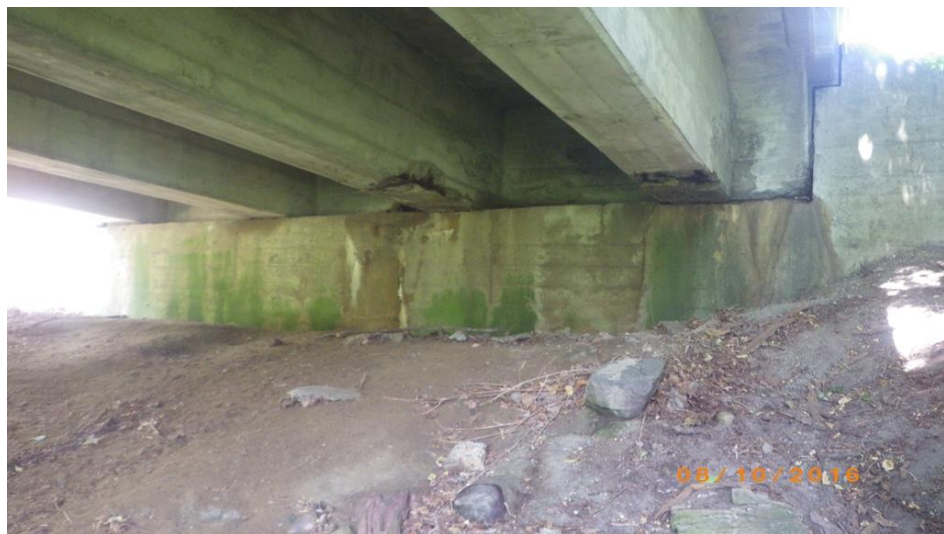
**Photo from Latest VTrans Inspection**

New Haven has not acted to address issue as of November 2017.

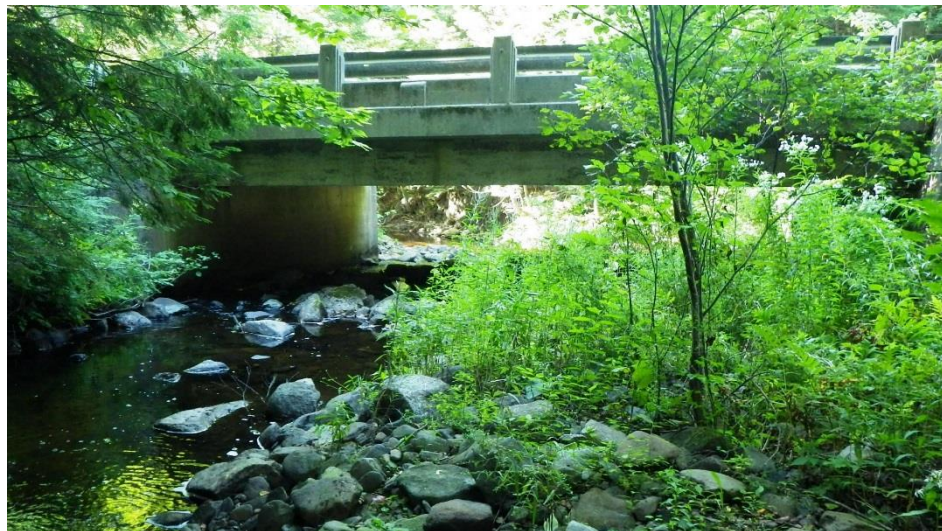
**Photo and Finding from 2014 VTrans Inspection**

Trees and brush on the upstream side should be removed from the channel.

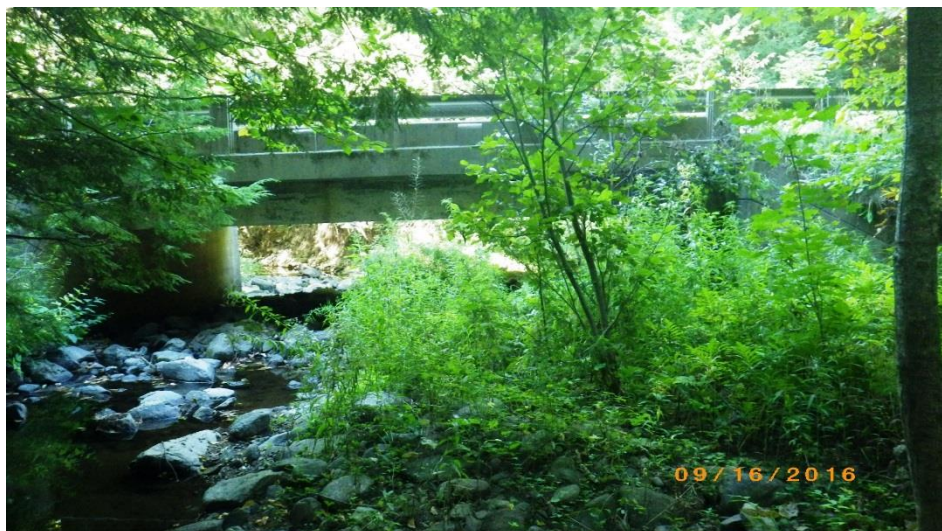
**Photo from Latest VTrans Inspection**

After consultation with the Vermont Department of Environmental Conservation, which did not approve removal of the trees and brush, Newfane did not take action.

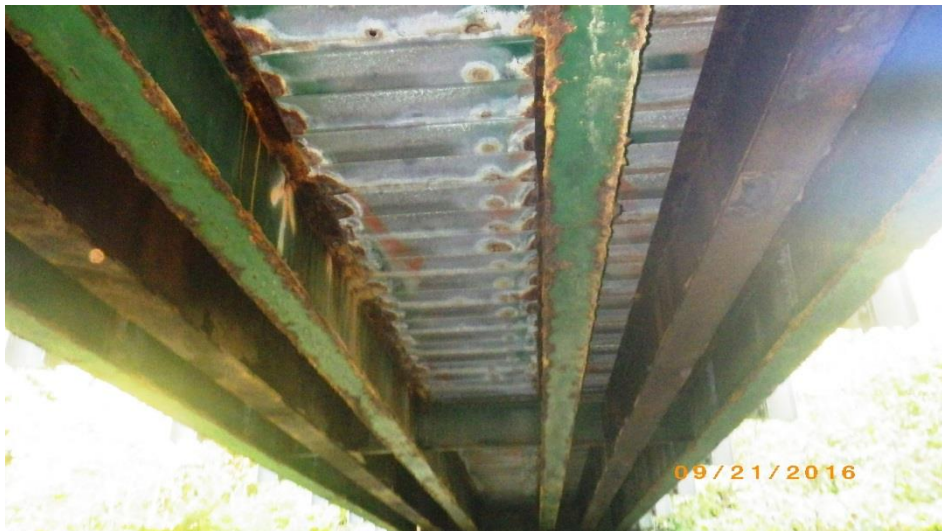
**Photo from Latest VTrans Inspection**

Newfane has not acted to address issue as of December 2017.

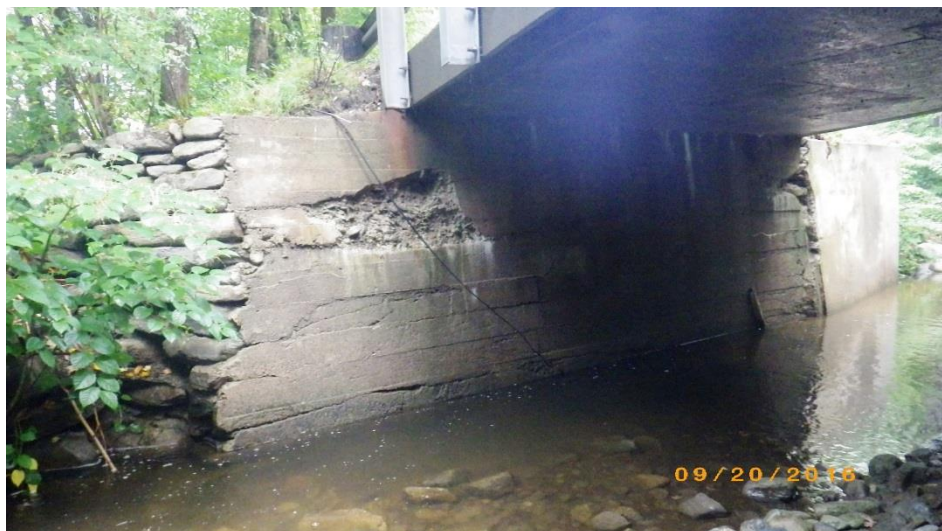
**Photo from Latest VTrans Inspection**

Newfane has not acted to address issue as of December 2017.

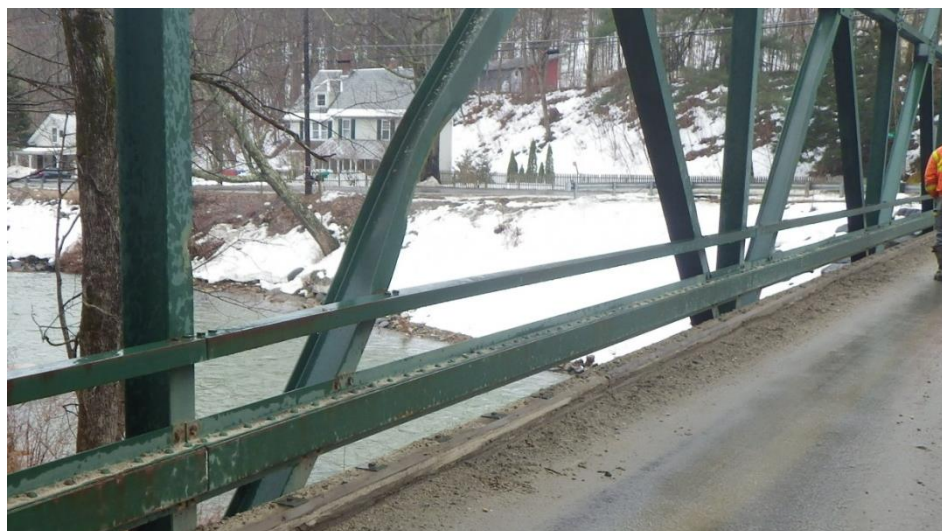
**Photo from VTrans Inspection 4/6/2017**

Newfane has not acted to address issue as of December 2017.

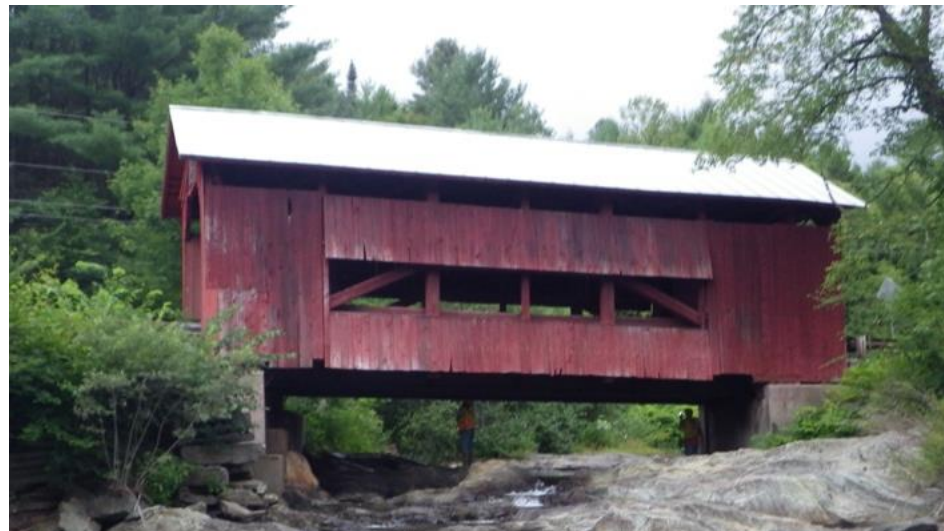
**Photo and Finding from 2014 VTrans Inspection**

Covered bridge portion needs reconstruction.

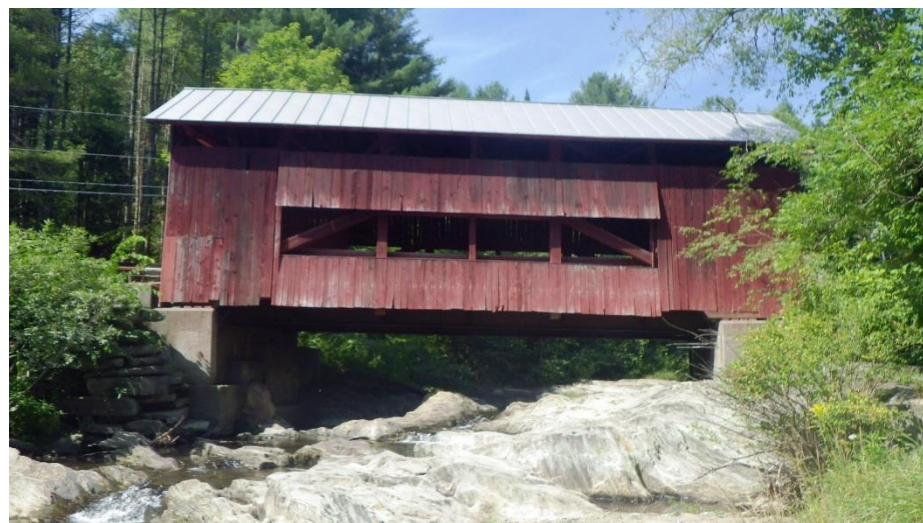
**Photo from Latest VTrans Inspection**

Northfield has not acted to address issue as of December 2017.

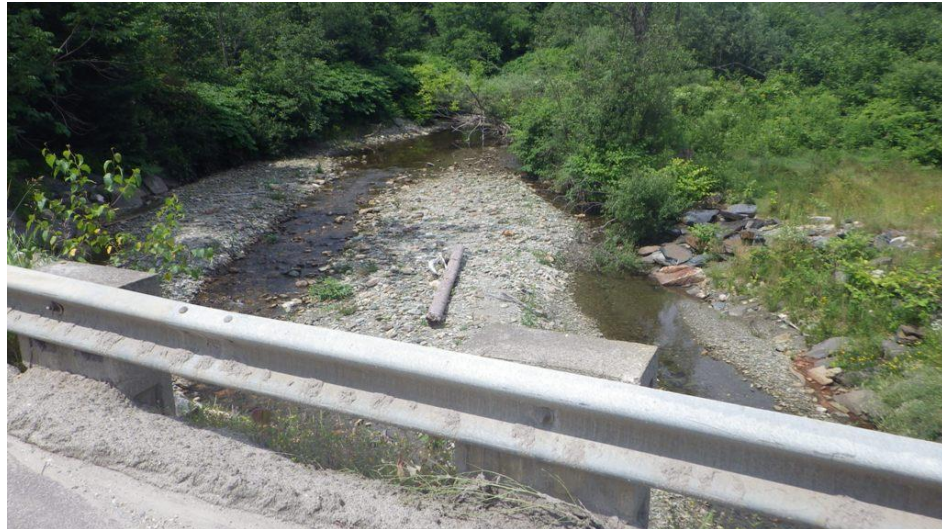
**Photo and Finding from 2014 VTrans Inspection**

Channel needs to be realigned.

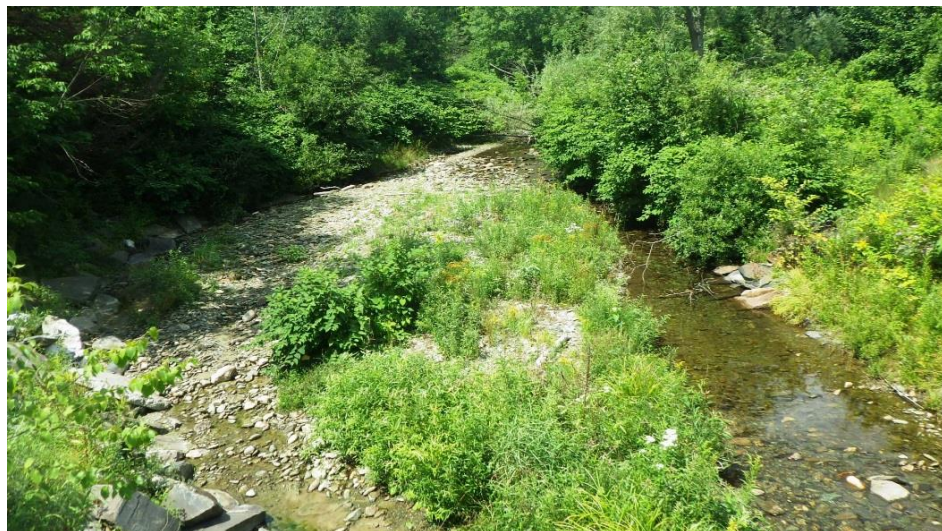
**Photo from Latest VTrans Inspection**

High-water event redirected the channel.

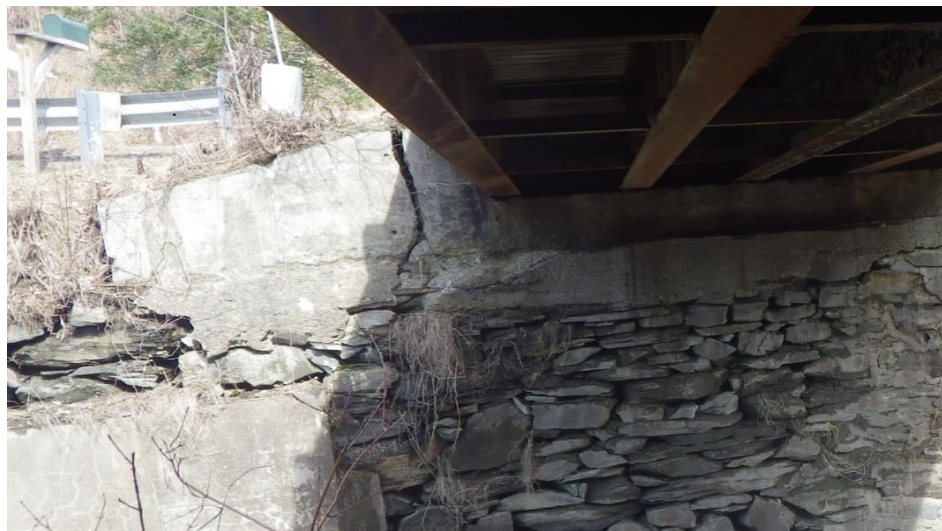
**Photo from Latest VTrans Inspection**

Northfield has not acted to address issue as of January 2018.

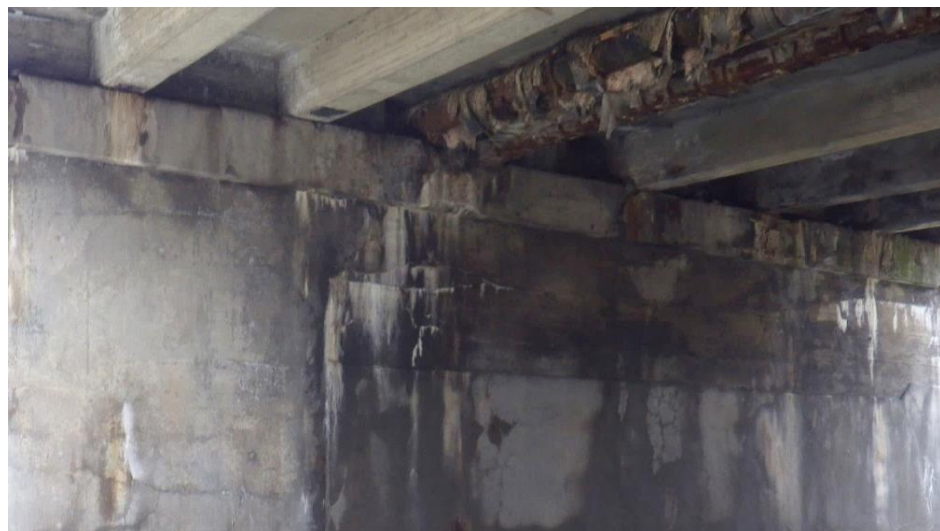
**Photo from Latest VTrans Inspection**

Northfield has not acted to address issue as of December 2017.

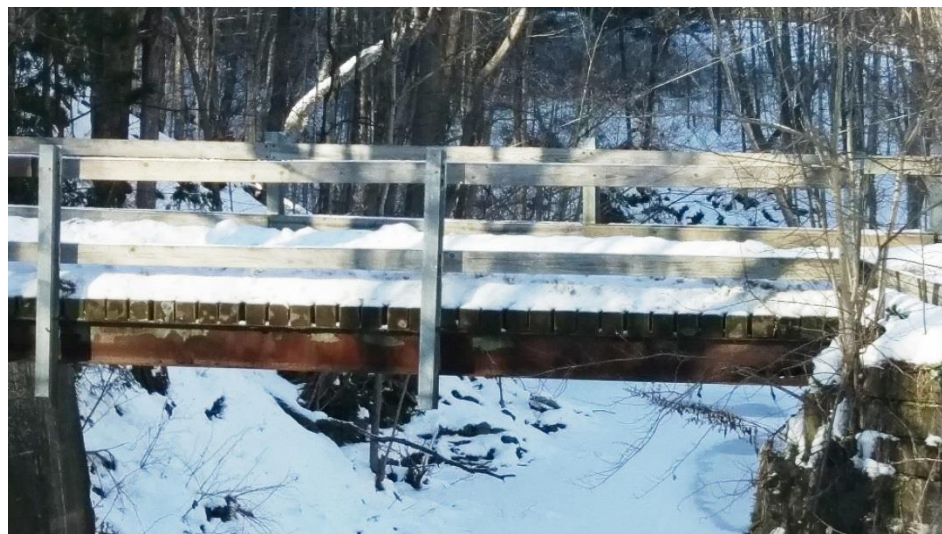
**December 2017 SAO Photo**

Northfield has not acted to address issue as of December 2017.

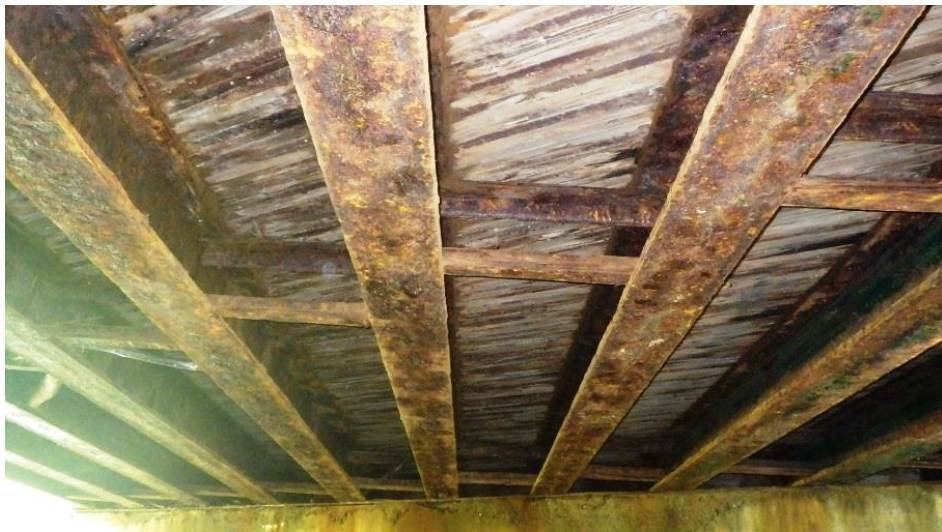
**Photo from Latest VTrans Inspection**

Beams need to be cleaned and painted due to heavy rusting,

Northfield has not acted to address issue as of December 2017.

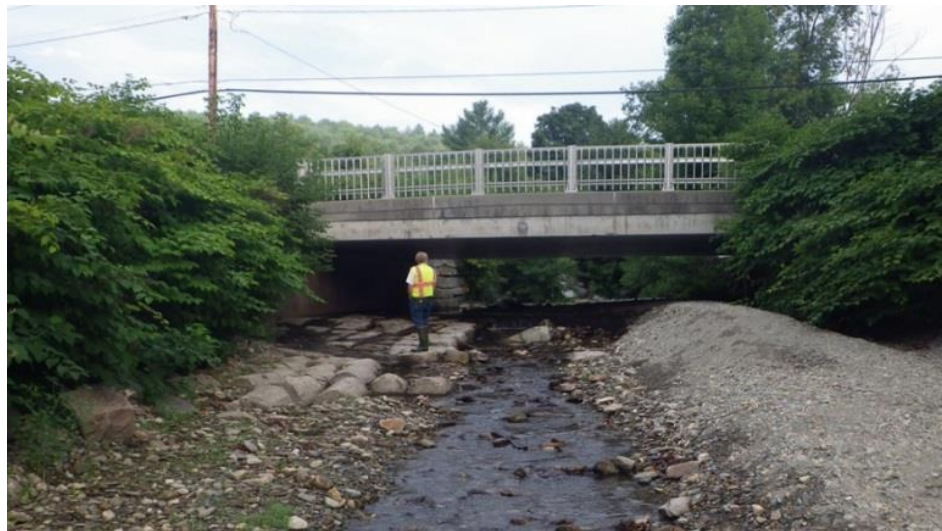
**Photo and Finding from 2014 VTrans Inspection**

Sediment build-up should be removed,

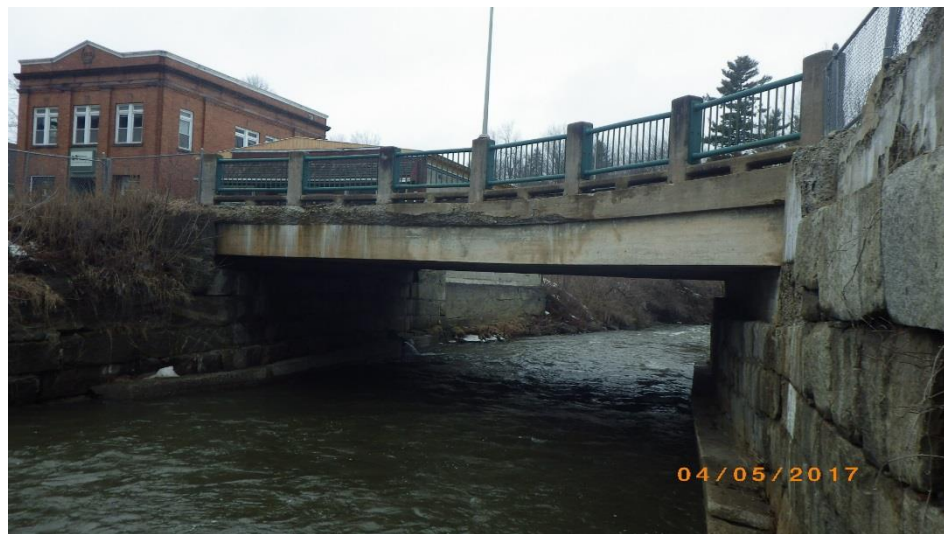
**Photo from Latest VTrans Inspection**

Deck deteriorating.

VTrans plans to replace bridge in 2019-2020 as part of the town highway bridge program.

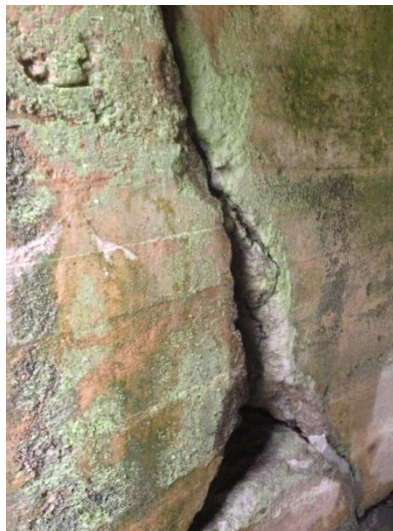
**Photo from Latest VTrans Inspection**

VTrans found abutment wall and footing damage but did not include this information in the report available to Randolph on VTransparency.

VTrans reported the abutment and footing damage in the report available to Randolph on VTransparency in 2017.

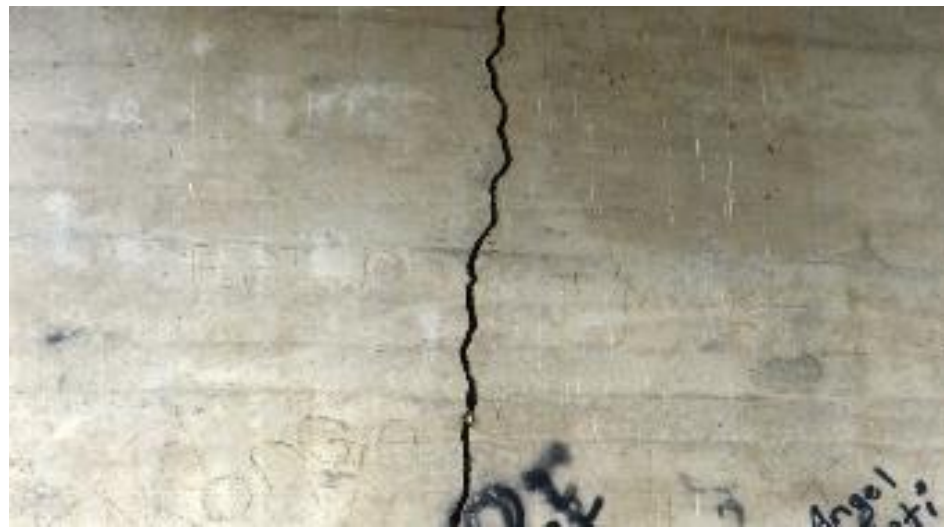
**Photo and Finding from 2015 VTrans Inspection**

The northern abutment experienced some additional forward movement in 2011.

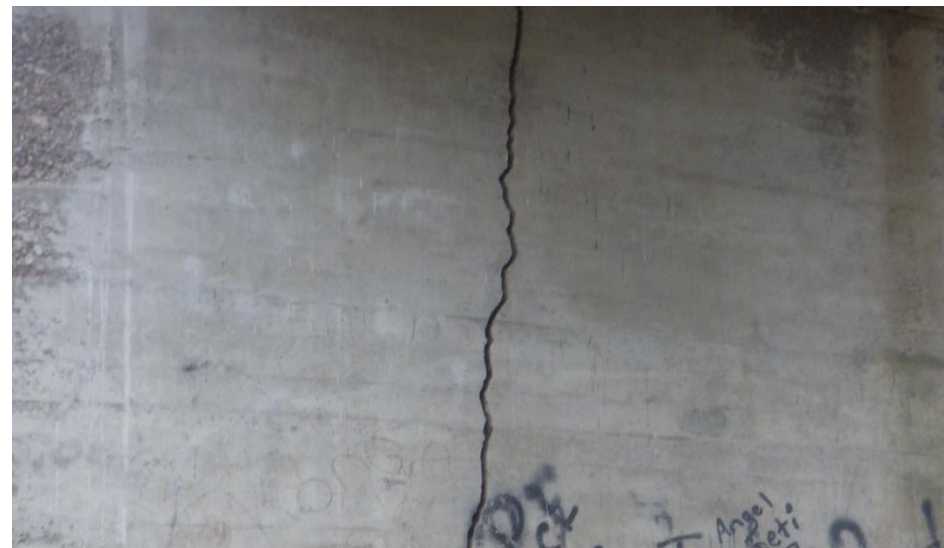
**Photo from Latest VTrans Inspection**

Randolph reported that it monitors and performs visual inspections of this bridge.

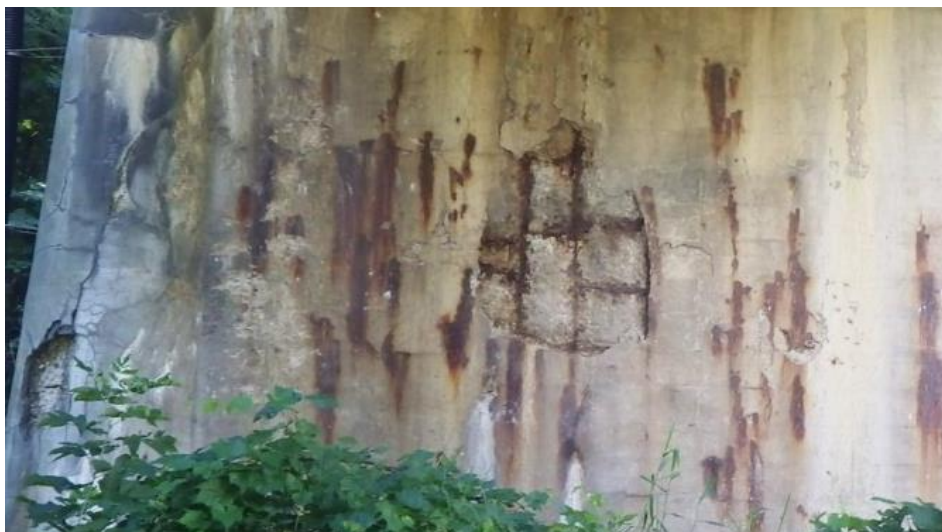
**Photo from Latest VTrans Inspection**

Pier columns need to be repaired as there is heavy cracking and concrete deterioration.

Rutland City has not acted to address finding as of January 2018.

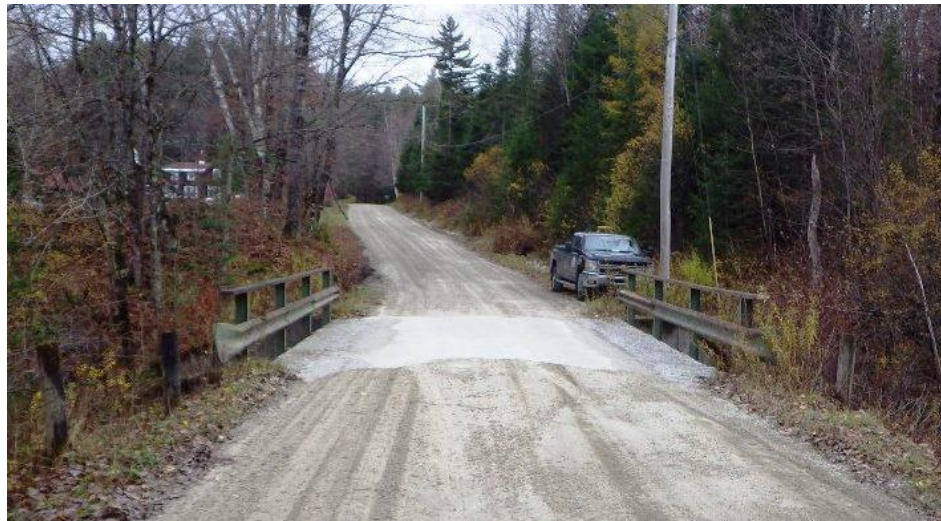
**Photo and Finding from 2014 VTrans Inspection**

Guard rail system needs upgrading.

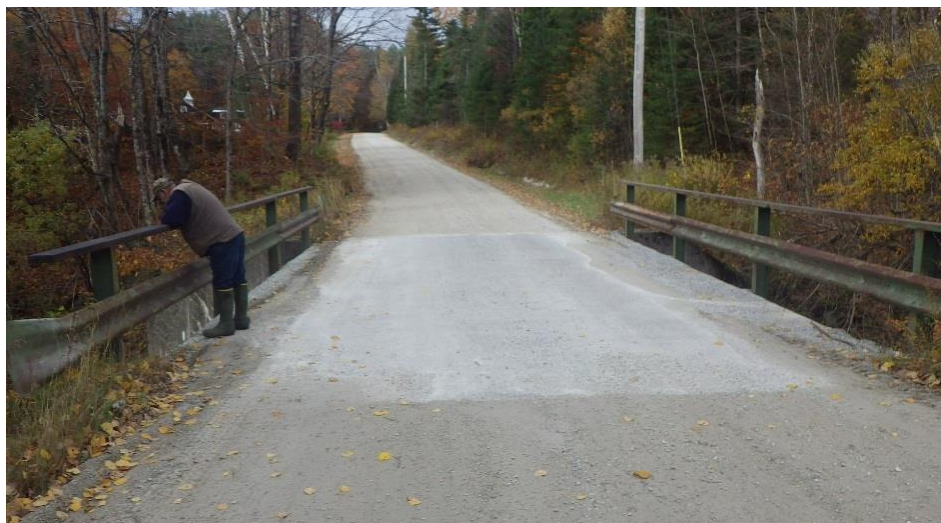
**Photo from Latest VTrans Inspection**

Shrewsbury has not acted to address issue as of November 2017.

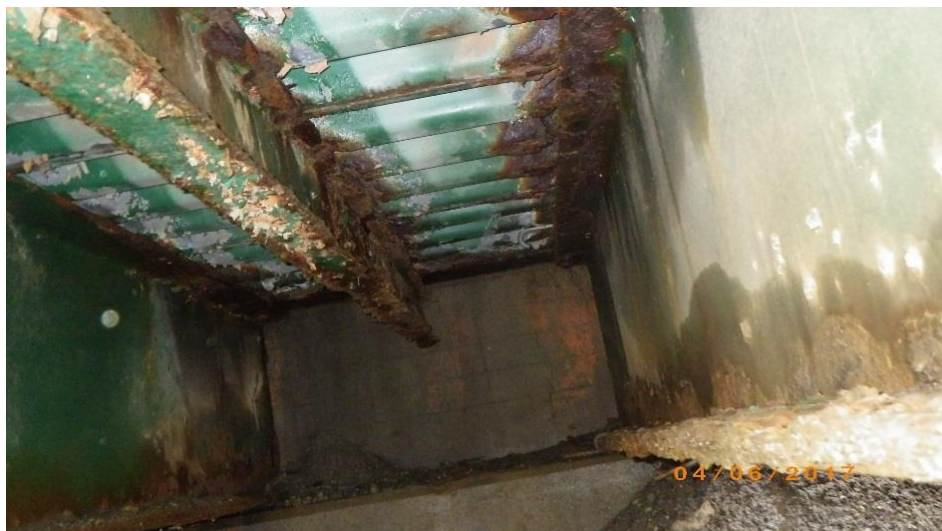
**Photo from Latest Inspection**

Deck and superstructure will need replacement in the very near future.

Utilizing a VTrans town highways structures grant, Townshend is in the process of replacing bridge; expected completion in 2018.

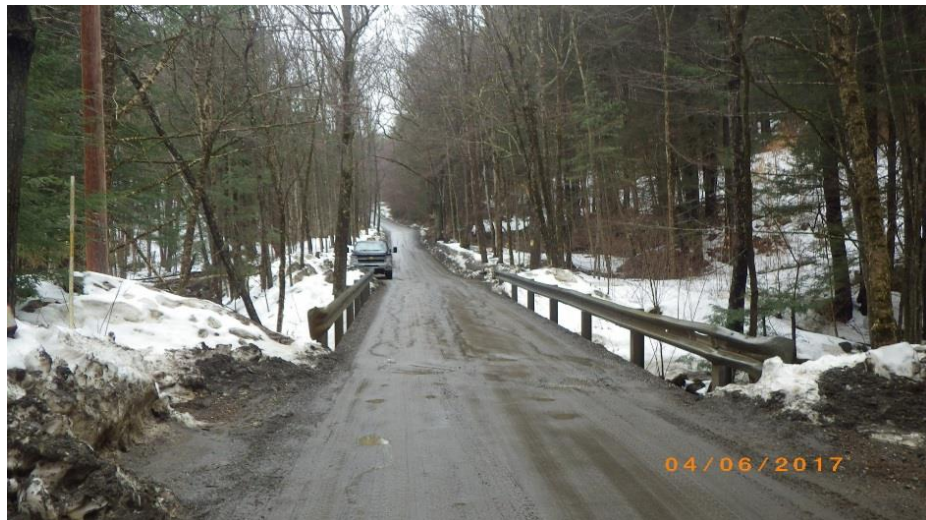
**Photo from Latest VTrans Inspection**

Bridge and approach rail should be replaced.

Townshend has not acted to address issue as of December 2017.

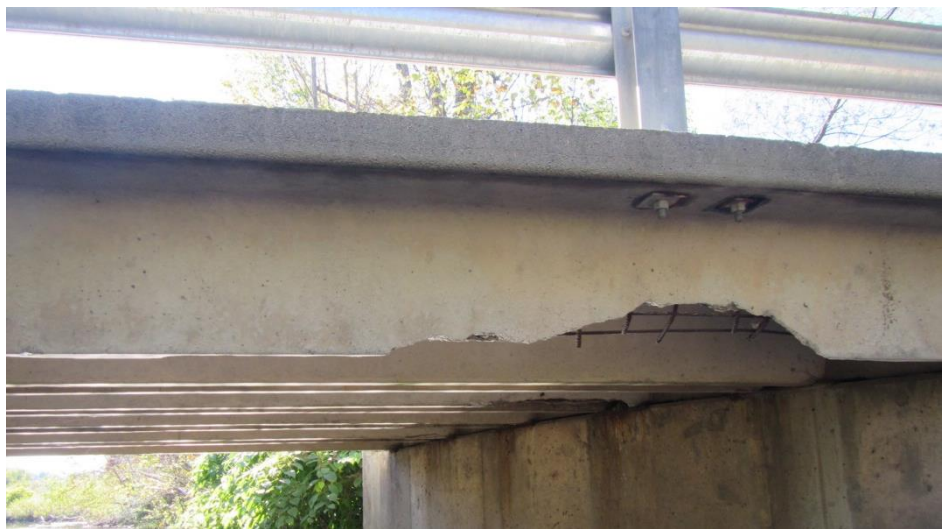
**Photo from Latest VTrans Inspection**

Tension cable is in good condition. Beam/cable unit should be replaced before tension cable rusts beyond repair.

Weathersfield has not acted to address issue as of November 2017.

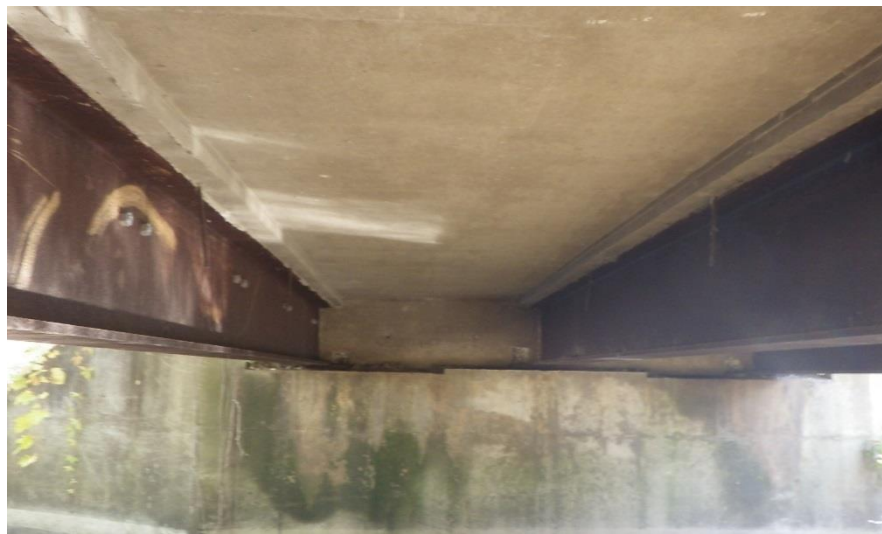
**Photo from Latest VTrans Inspection**

West Rutland has not acted to address issue as of January 2018.

Consider cleaning and painting and greasing the last few feet of the beam ends to deter further corrosion.
